# Facility Development Plan Issues and Opportunities

Dean's Marsh Community Hub

Surf Coast Shire

Oct 2022 REV 2

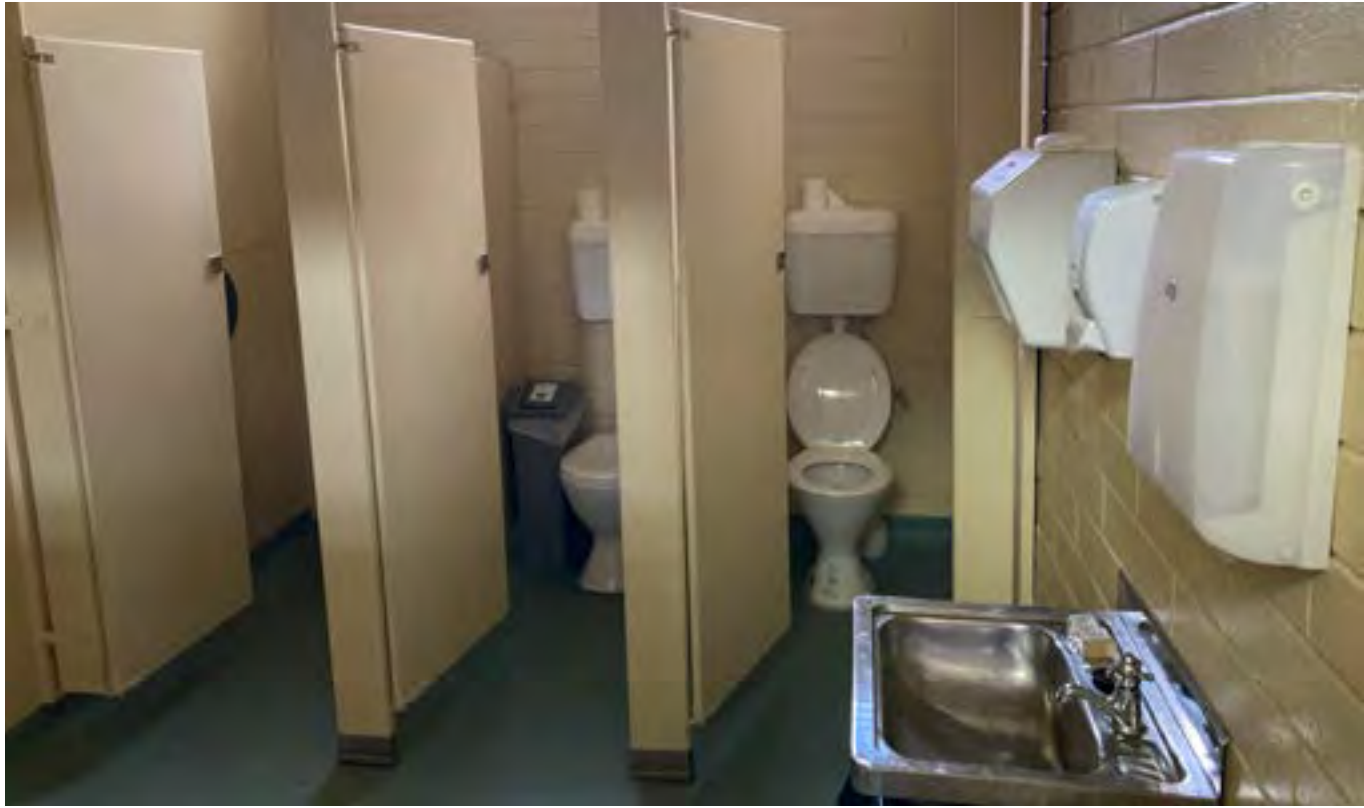
The joinery and fit out to the Kitchen area is aged and of a low amenity. The fit out to the Toilets has basic partition structures and painted face brickwork, with sheet vinyl to the floors.

Toilets

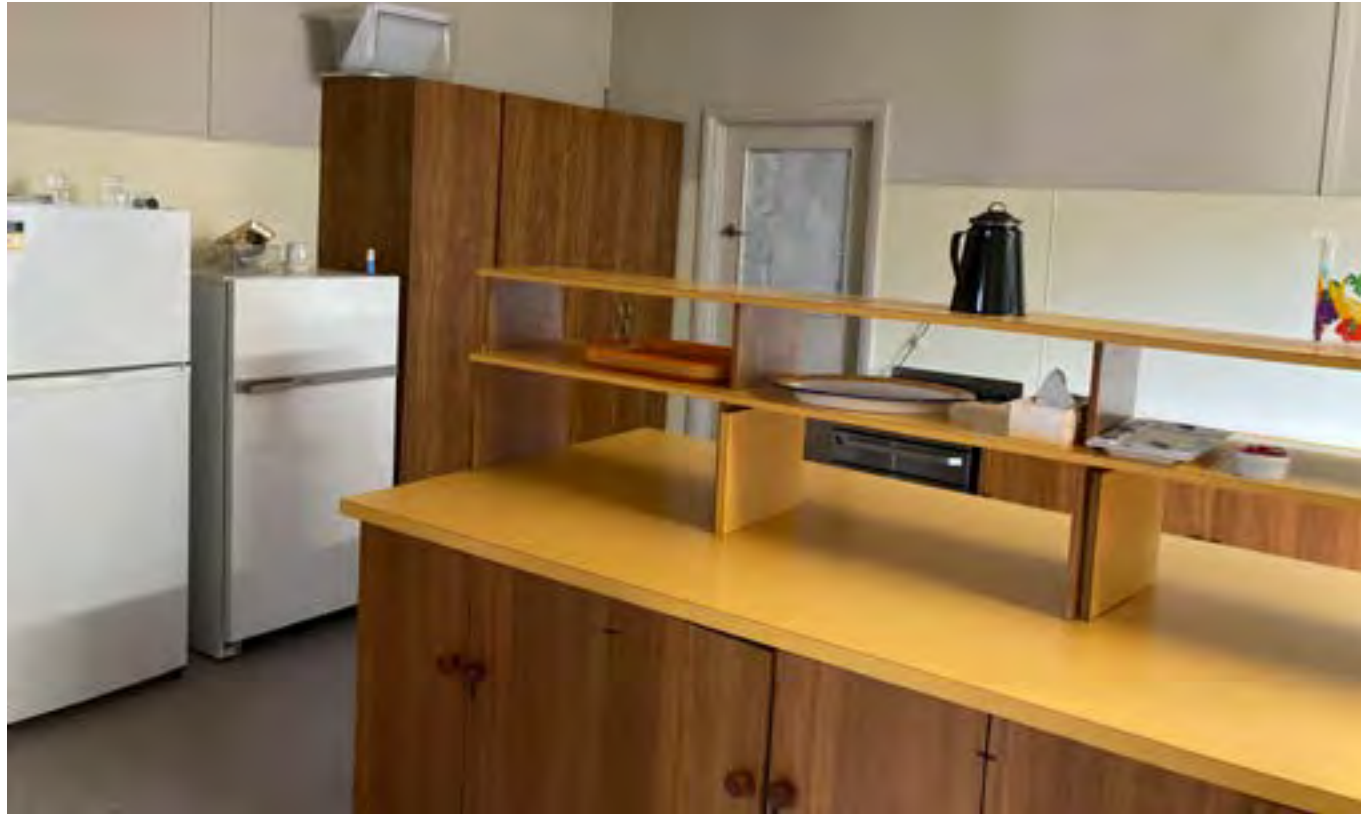
Kitchen interior

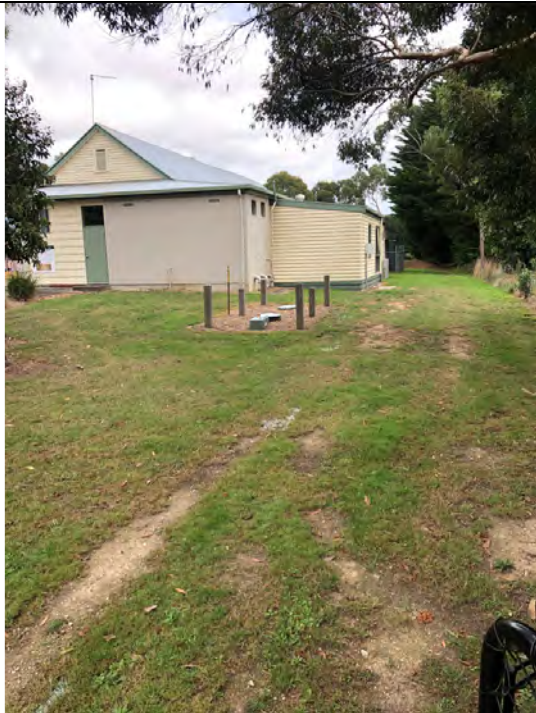
The capacity of the system for any redevelopment would need to be assessed with local council/EPA requirements, however it is likely that the system may need to be upgraded with the size and function of the facility increasing.

Figure 11- Onsite wastewater treatment plant located in NE corner of site

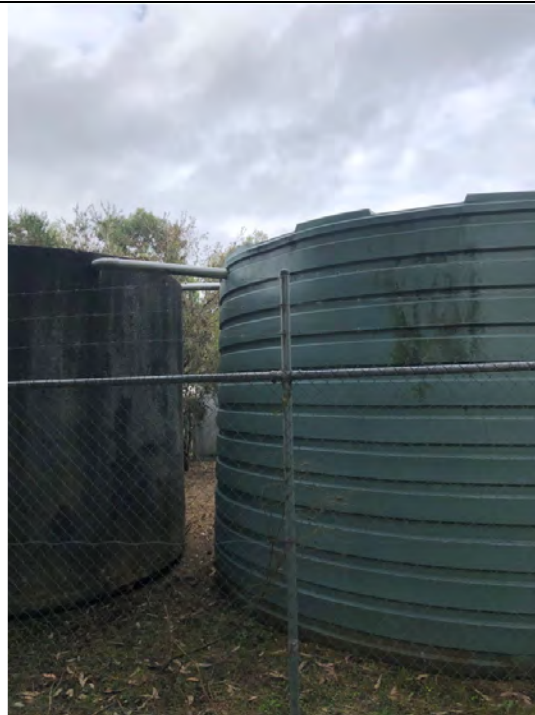
Figure 14- Rainwater tanks of varying age, type and condition located in tank farm

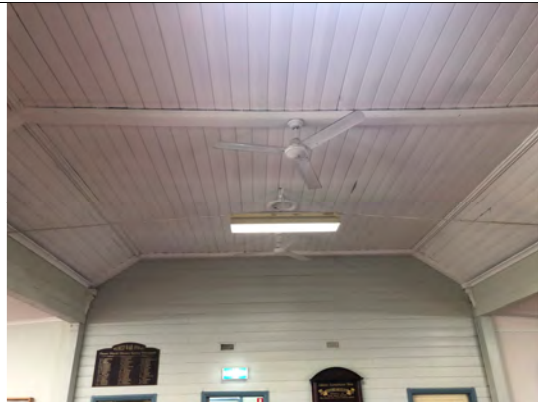
There are no electrical services or infrastructure that would be proposed to be retained or reused in any redevelopment of the Community Hall. The age and condition of the majority of services appear to be relatively old and in average to poor condition. The current switchboard is not provided with individual RCD protection to lighting and power circuits

Figure 19- Existing lighting & ceiling fan in community hall

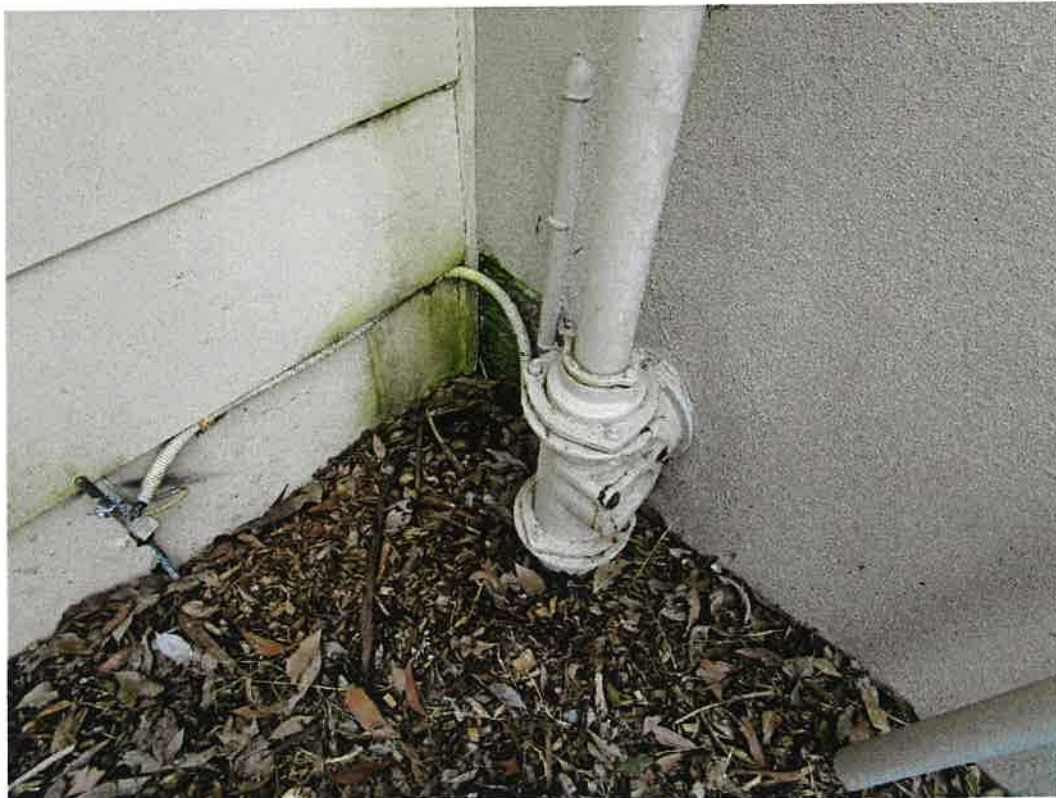
**Photo 4; South east re-entrant corner. Algal growth indicating high moisture levels.**

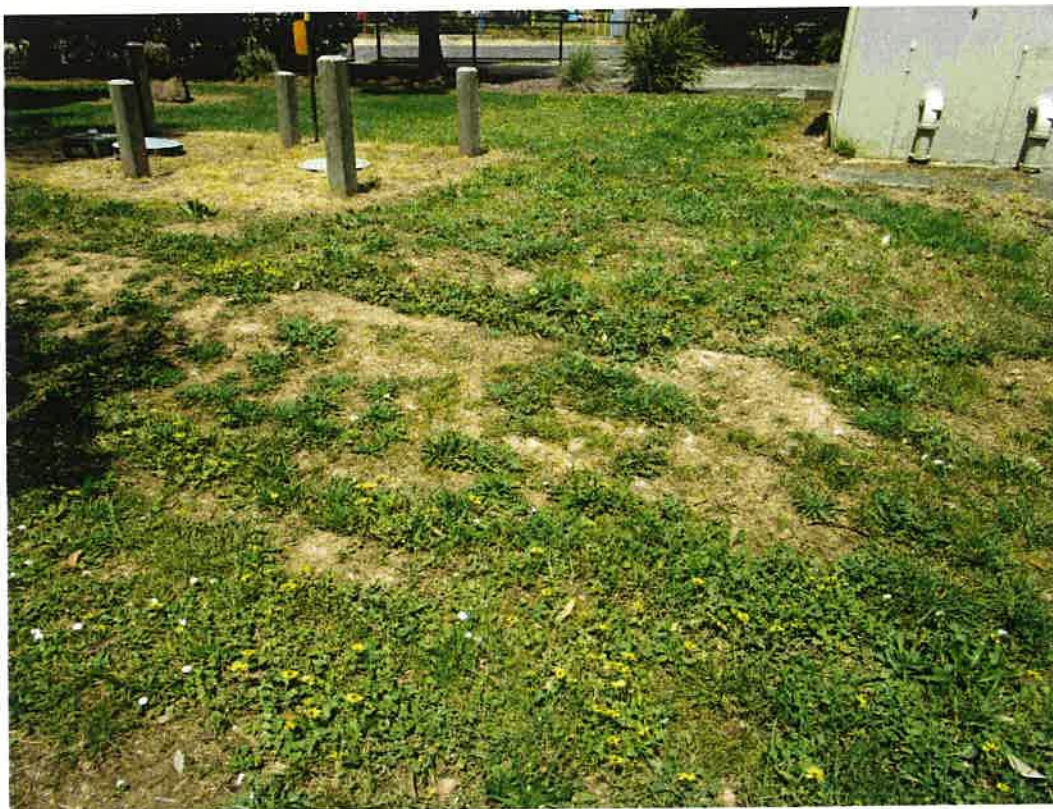
**Photo 5; Septic tank location, within bollards. Uneven soil surface allowing for water ponding.**

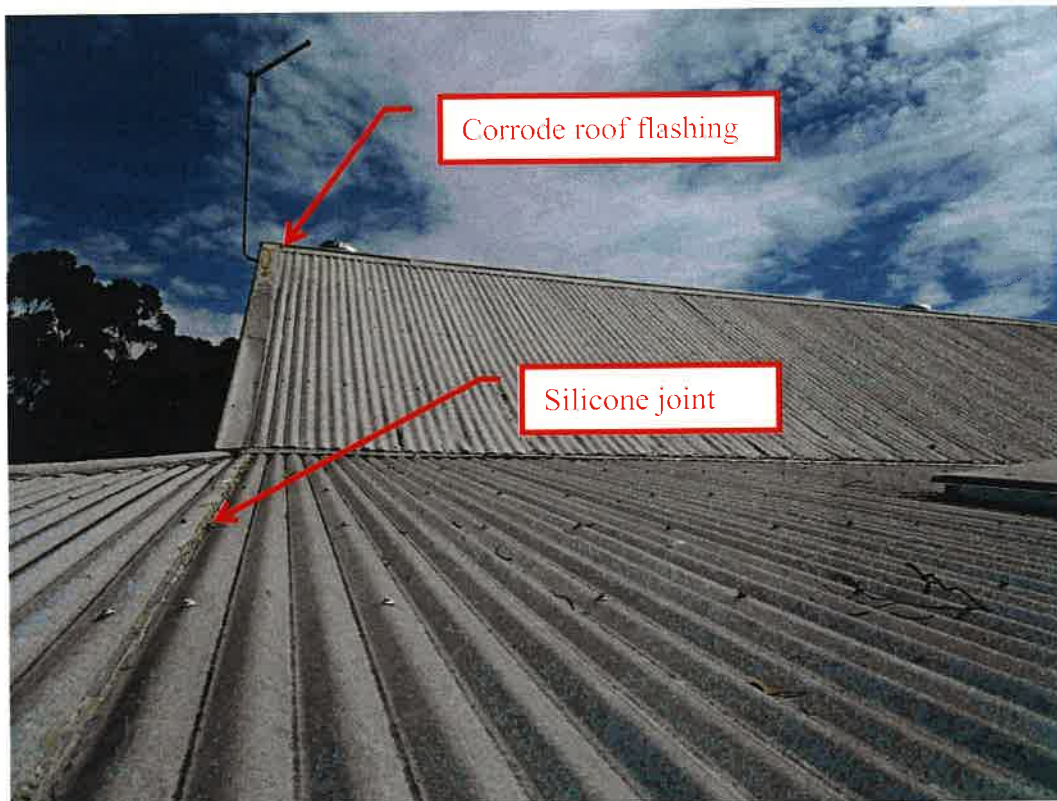
Photo 10; North side roof. Silicane joint. Corroded roof flashing.

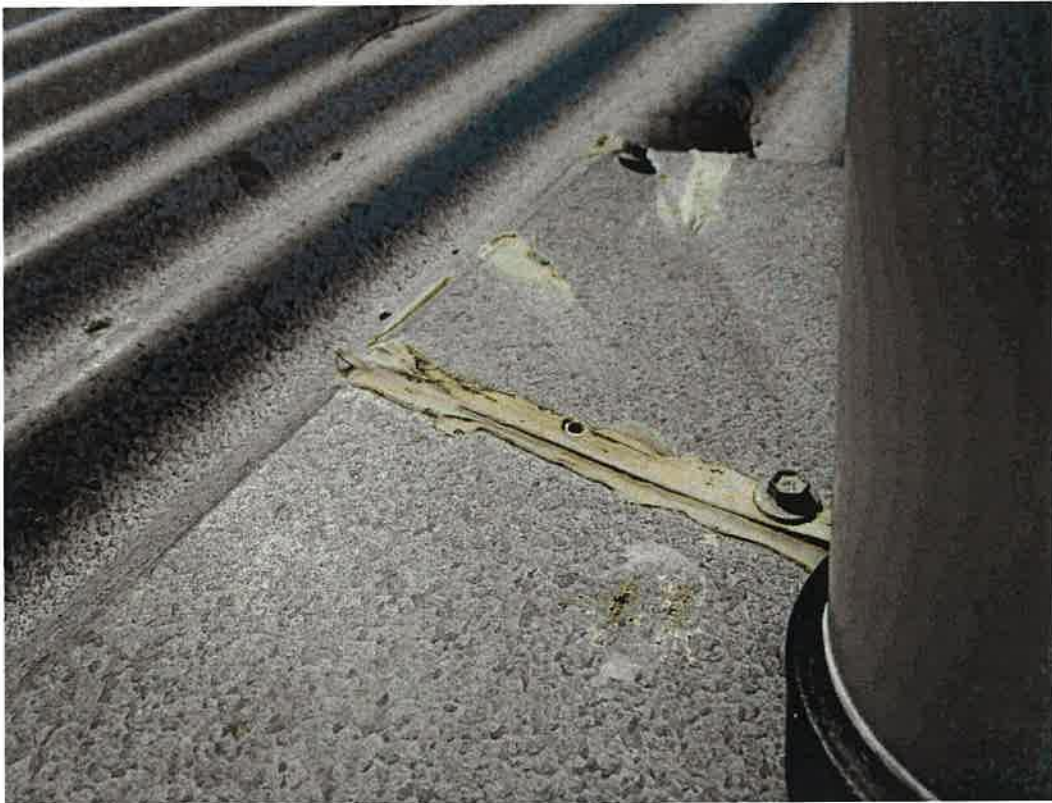
**Photo 11; Example of poorly installed flashing. Missing roof screw and no pop rivets to hold sections together. Flashing not wide enough to extend to next corrugation fully. Screw at top not into top of corrugation.**

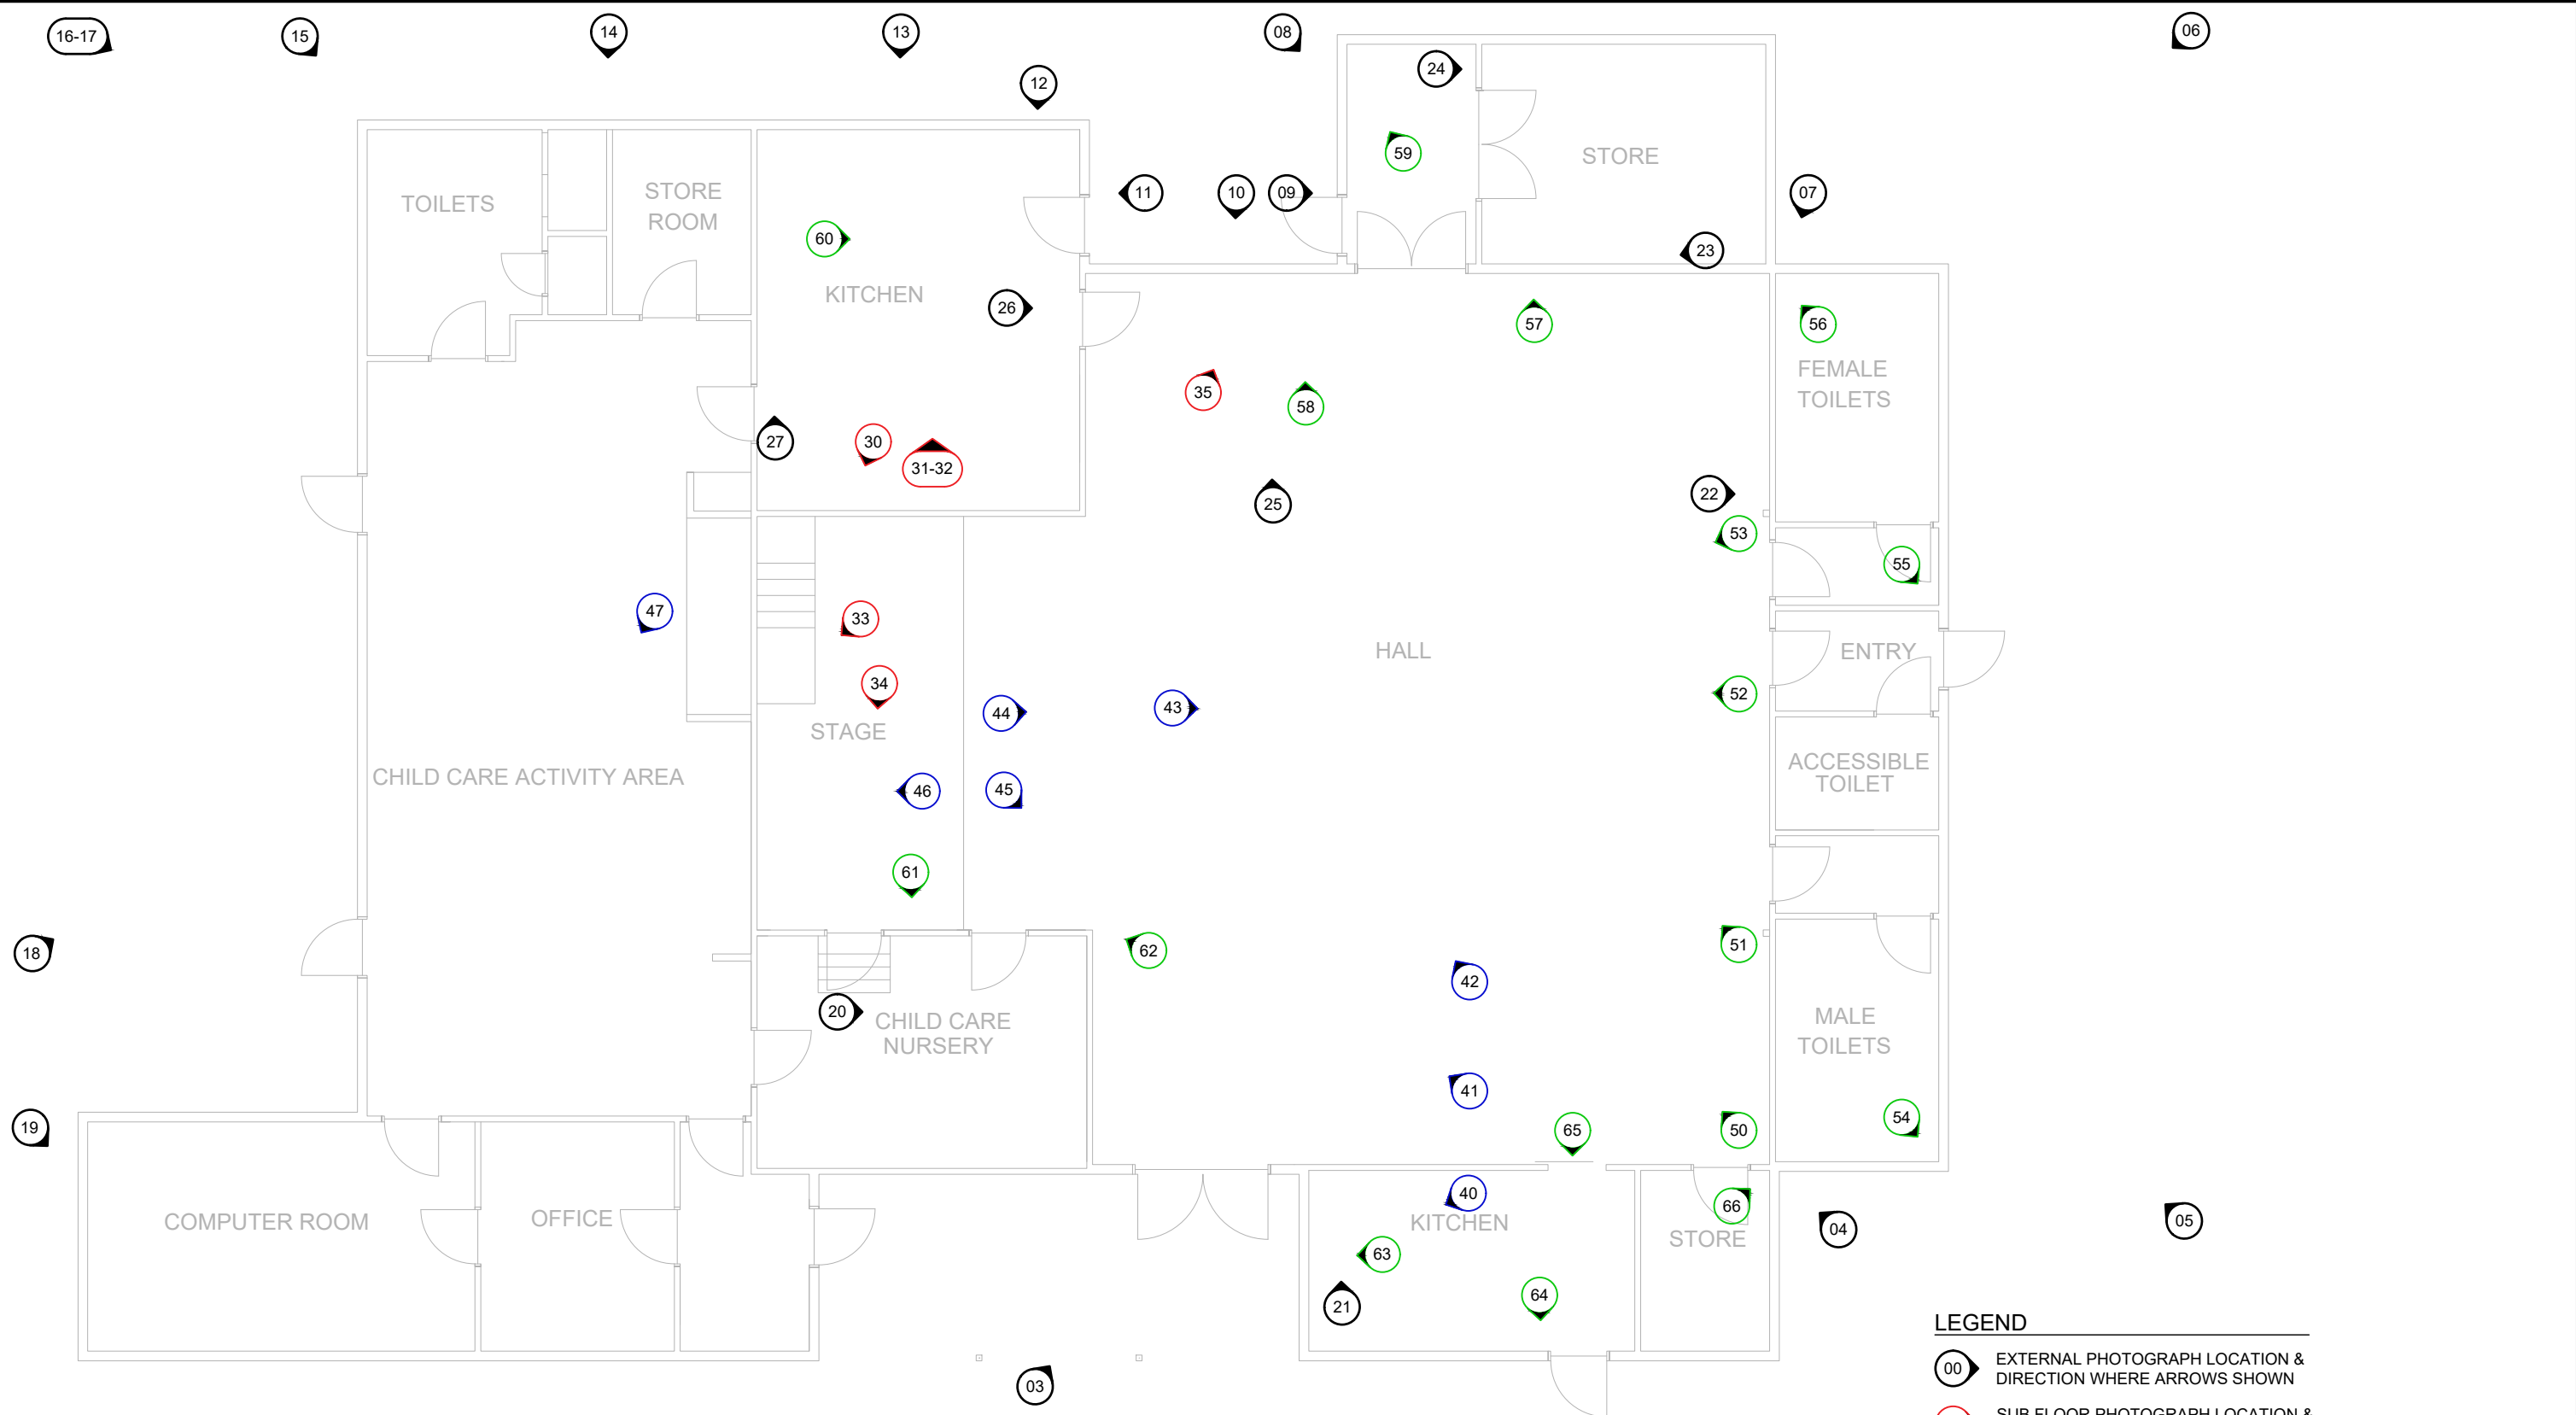
DAMAGE & PHOTOGRAPH LOCATIONS

| OBSERVED ISSUES | |
|---|---|
| NOTE: THE OBSERVED ISSUES NOTED ABOVE IS A NON-EXHAUSTIVE LIST. THIS DRAWING SHALL BE READ IN CONJUNCTION WITH THE BUILDING CONDITION REPORT (REFERENCE 23688_F1). | |
