Erosion Hazard Report

Flood Mitigation Adaptation for Painkalac Creek Estuary, Aireys Inlet

Surf Coast Shire

16 April 2025

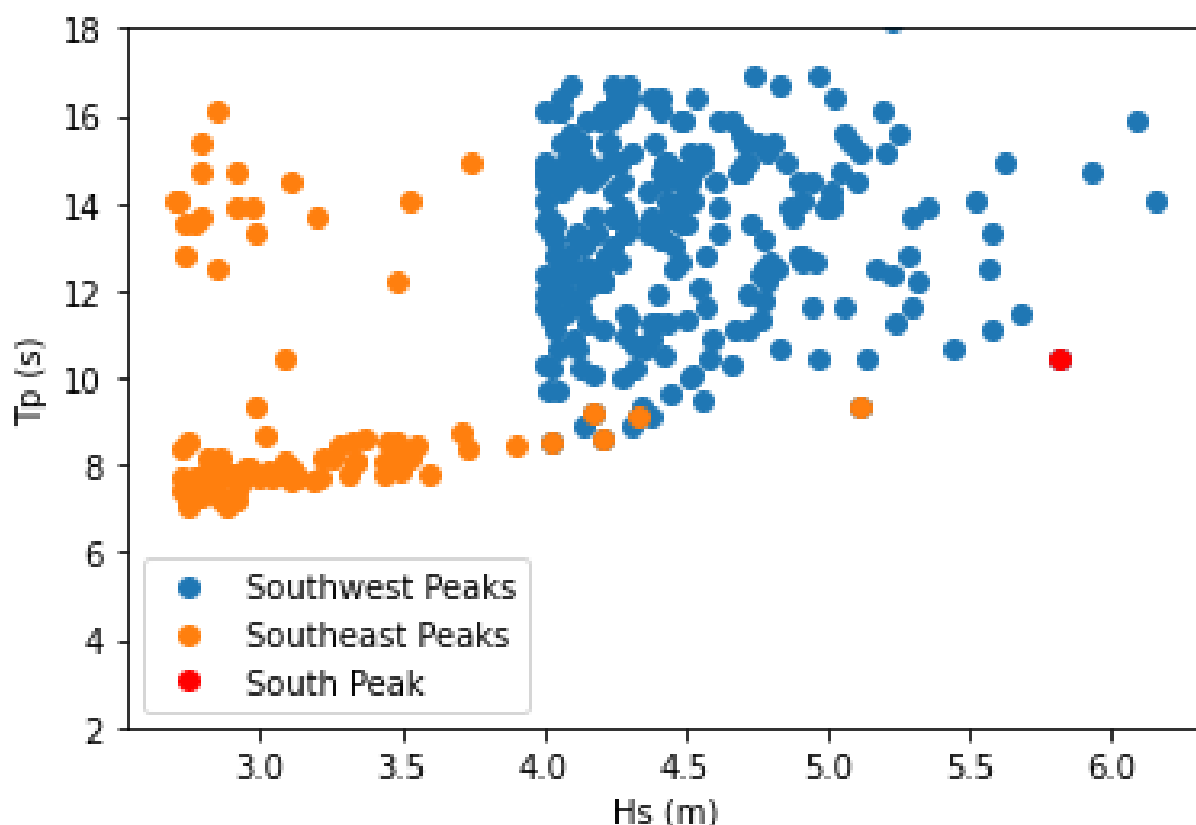
Figure 3-1 Peak Wave Period Analysis of Waves Extracted 10 km offshore in Bass Strait

Analysis of wave period of the extreme waves at the data extracted 10 km offshore indicates there are two distinct subsets of wave sources, the southwest and southeast, with the wave period varying based on where the wave originates. The southwest waves, which are swell waves propagating into Bass Strait from the Southern Ocean, typically have larger wave periods, between 10 s and 17 s, while the southeast waves, which are wind waves generated locally across Bass Strait, have smaller wave periods of around the 8 s to 10 s (Figure 3-1).

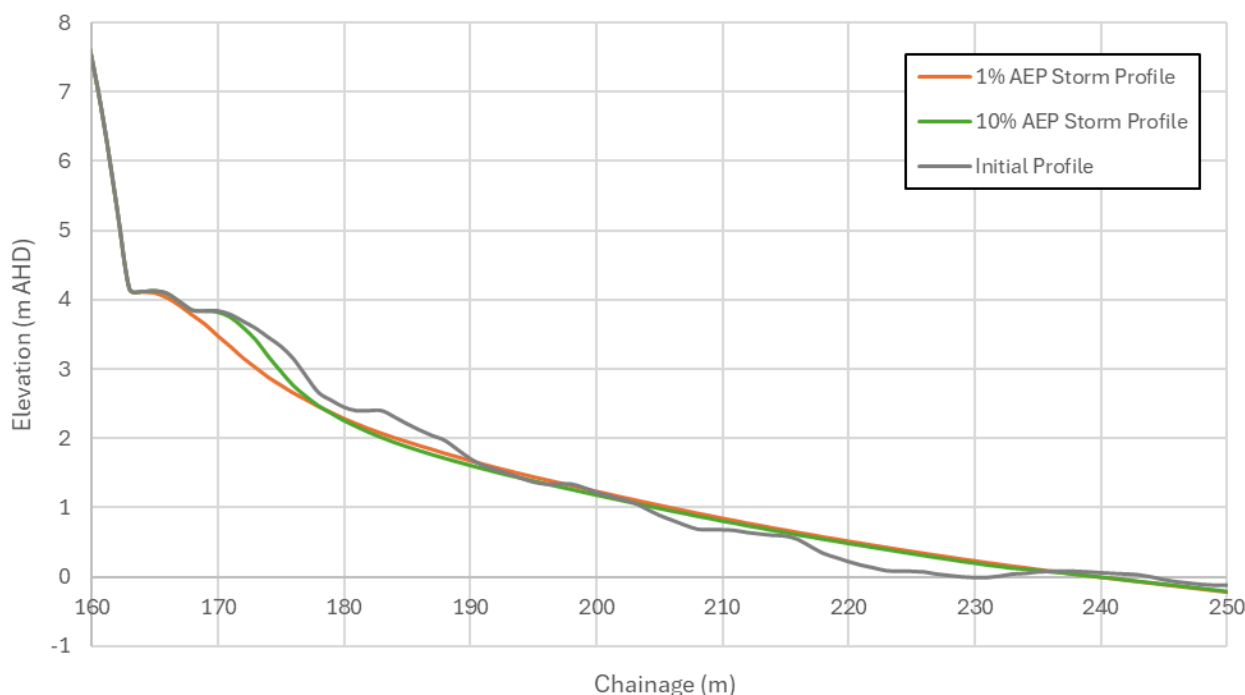
Figure 3-3 Example SBEACH Profile for CGC23 for the 1% and 10% AEP Event.

Results of the SBEACH modelling of the setback distances for the 1% AEP and 10% AEP events are presented in Table 3-3. These distances have been calculated as the distance between HAT and the most landward spot that experiences erosion.

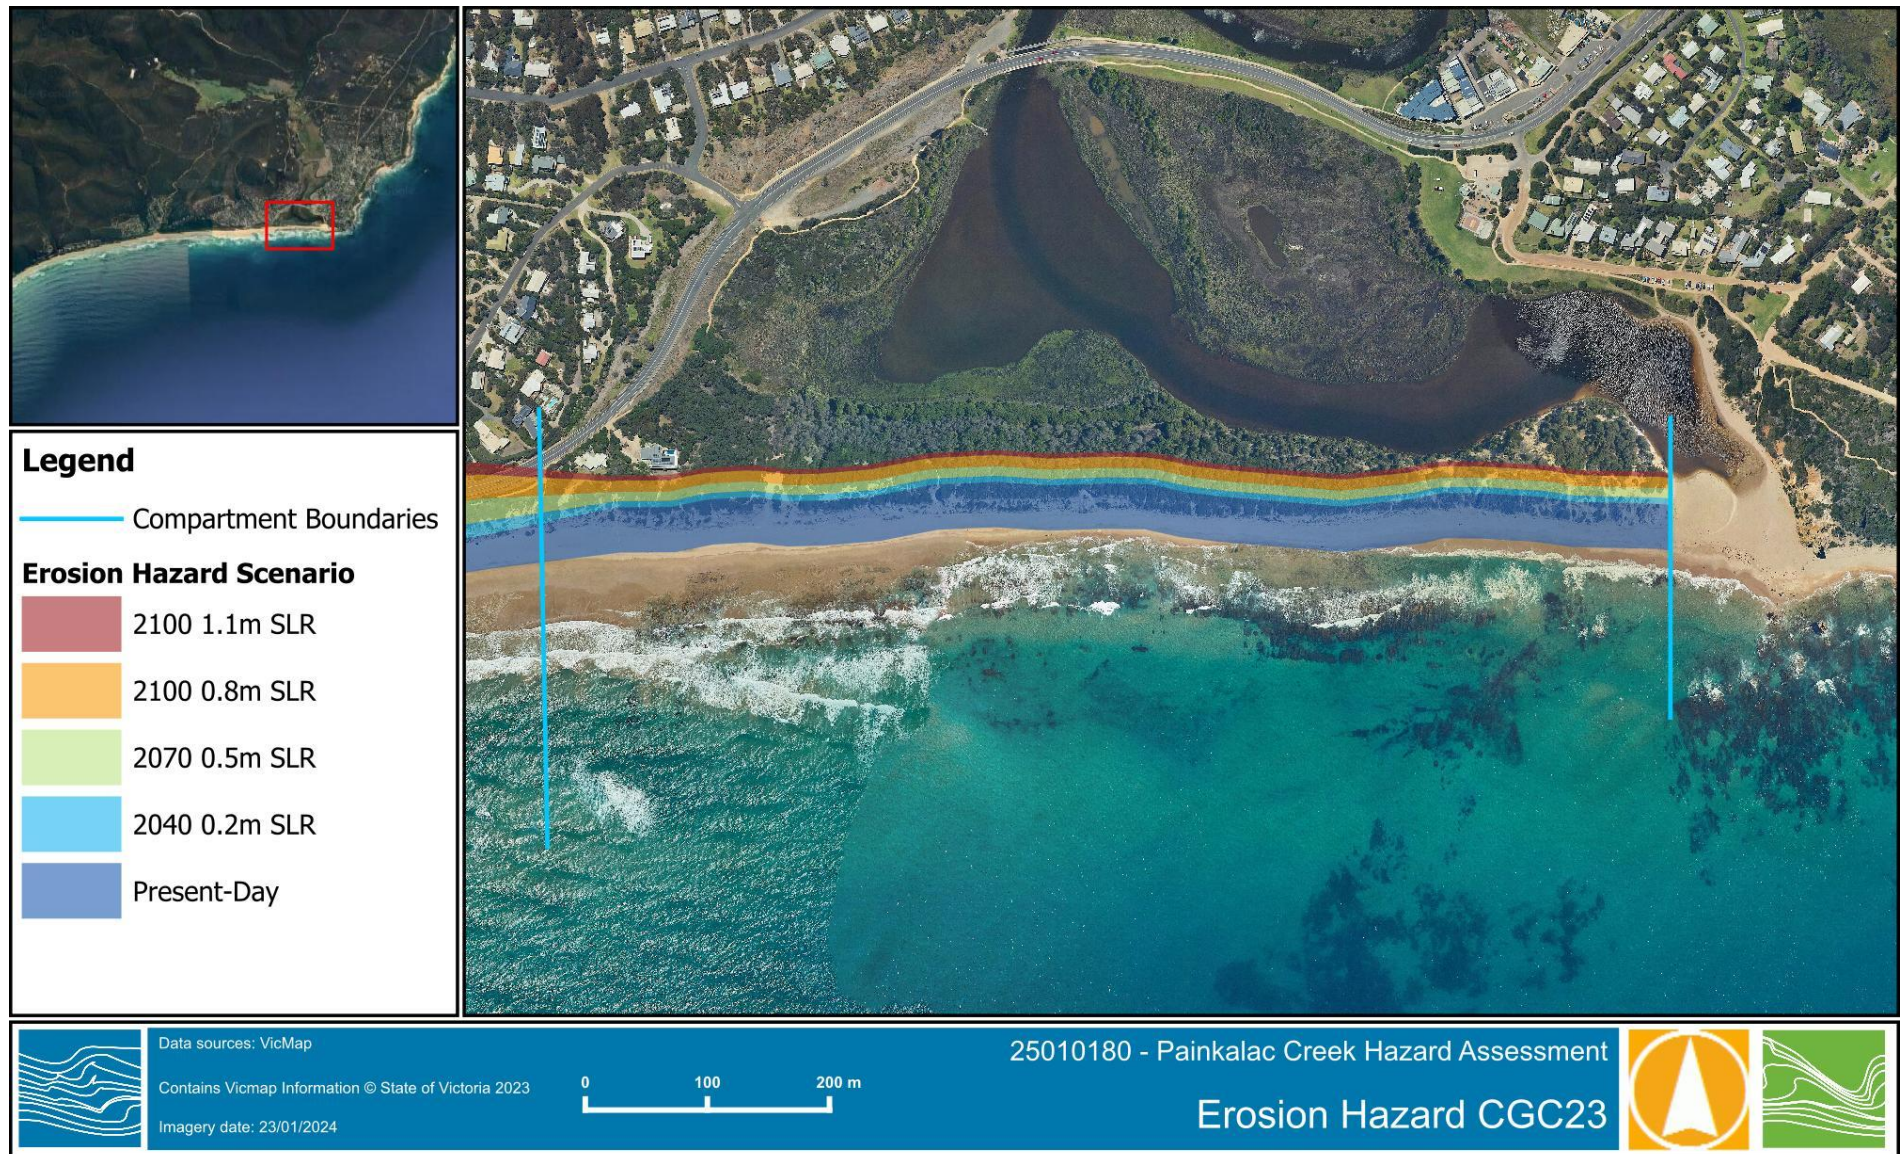
Figure 4-3 Coastal Erosion Hazard Area for CGC23

Table 4-1 presents a summary of the total erosion setback values for each compartment and planning horizon for the open coast sandy beach sections of the study site. The erosion hazard extents are presented in Figure 4-1 to Figure 4-3.

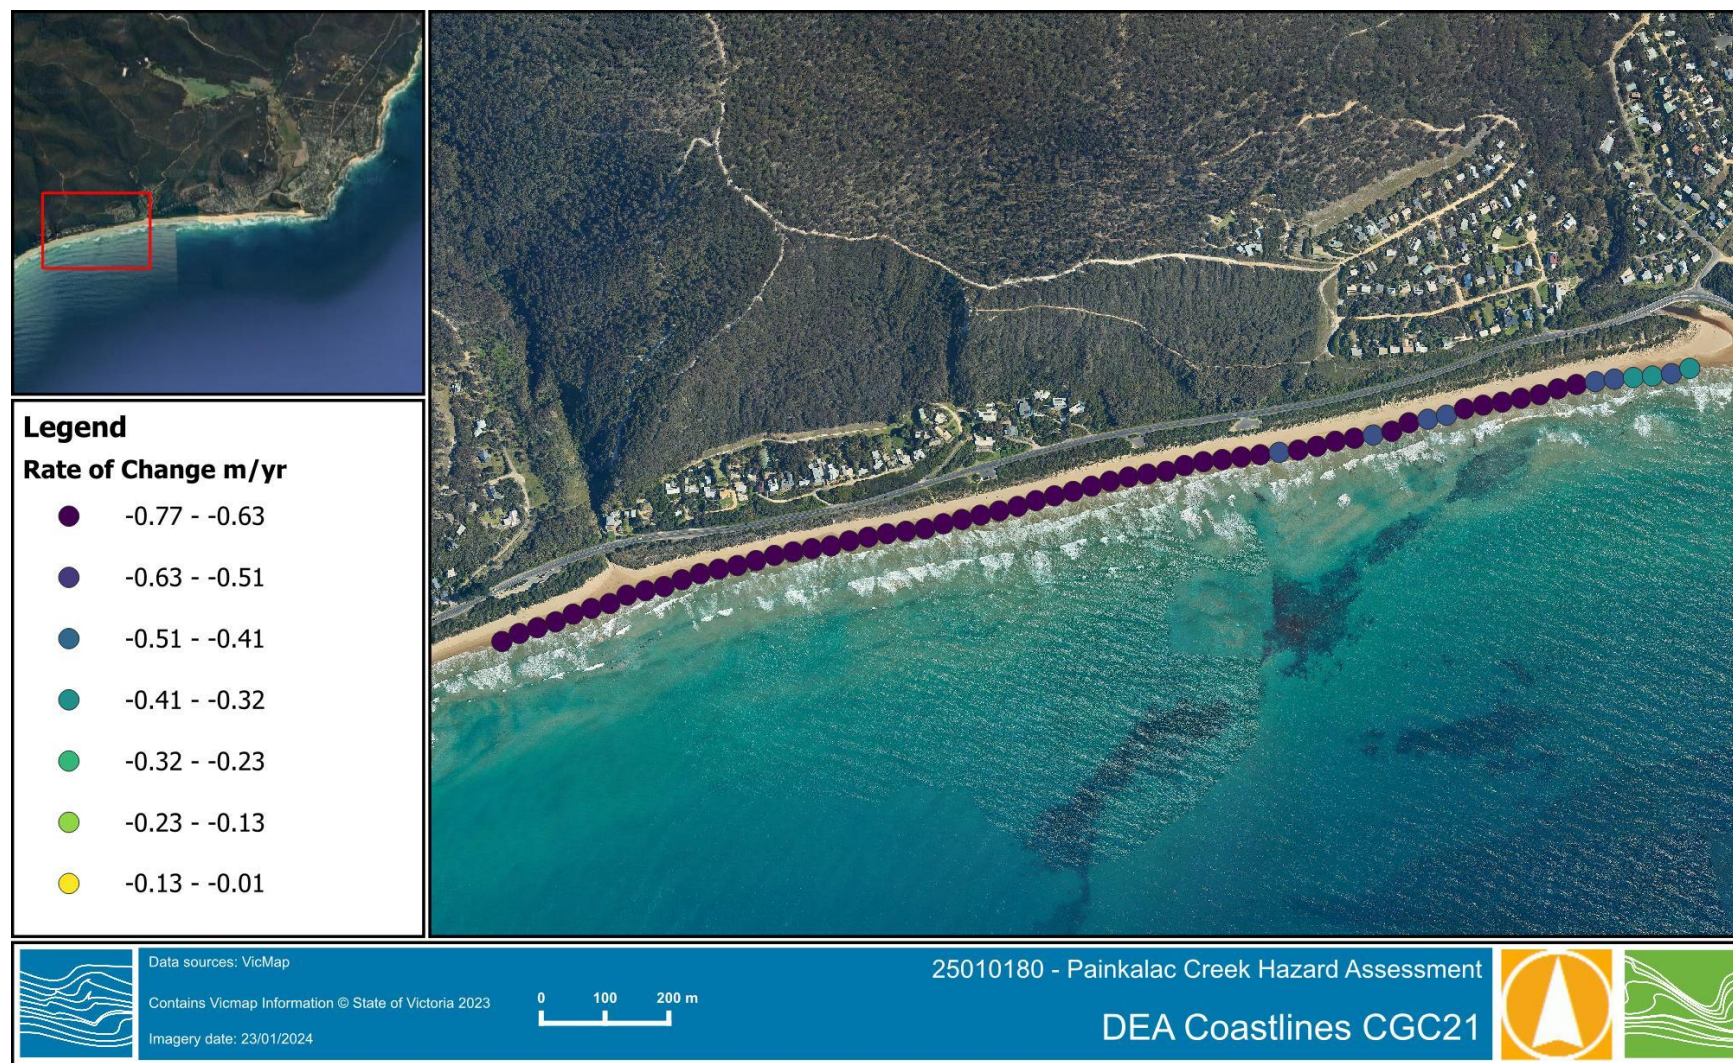
Figure A-1 DEA Coastlines CGC21

The average rate of change from the DEA Coastlines dataset per CGC is summarised in Table 3-4 with spatial data for each CGC presented in Appendix A.

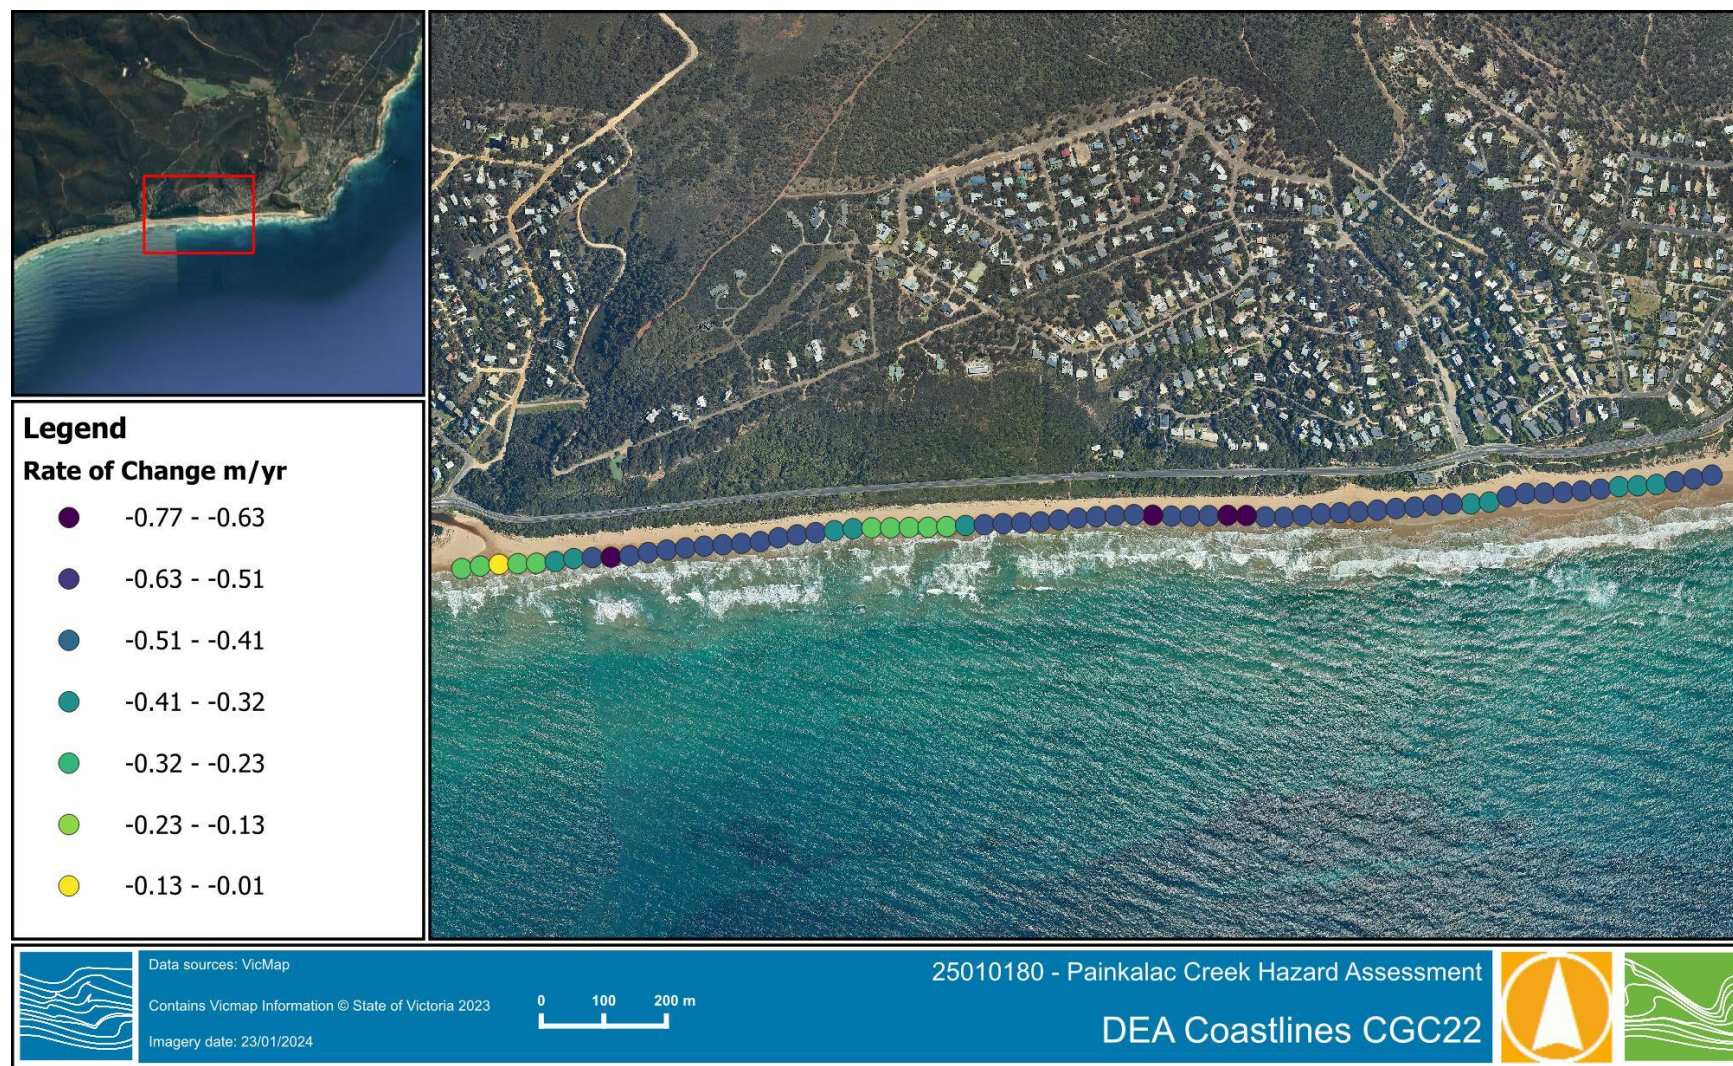
Figure A-2 DEA Coastlines CGC22
