# Facility Development Plan Issues and Opportunities

Dean's Marsh Community Hub

Surf Coast Shire

Oct 2022 REV 2

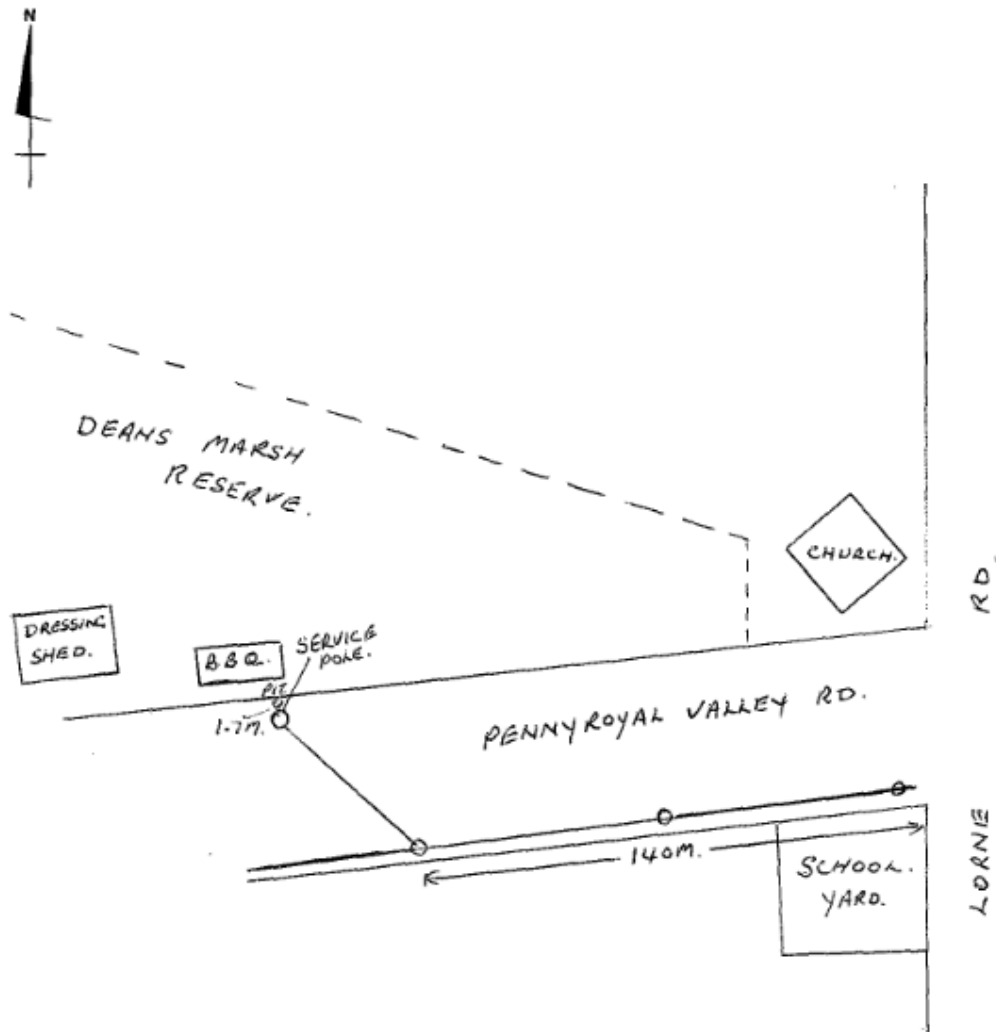
Figure 1- Authority overhead Power supply in Pennyroyal Valley Road serving the meter panel in the Reserve

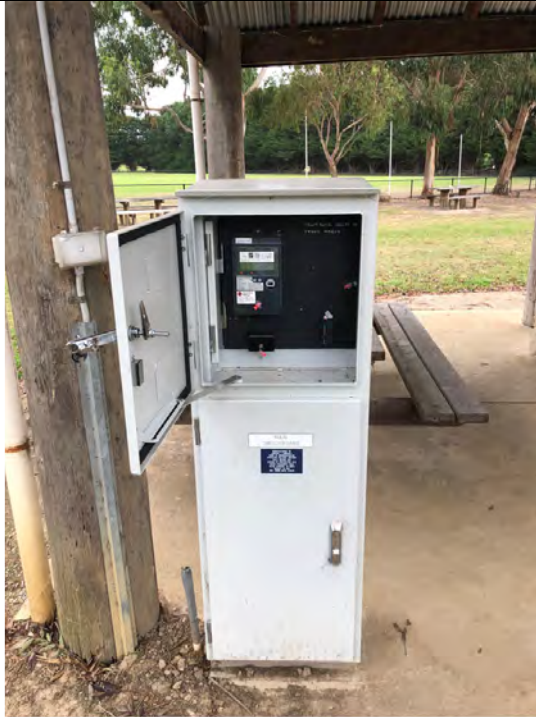
Figure 2- Authority meter panel installed in 2021 located in picnic shelter in Reserve

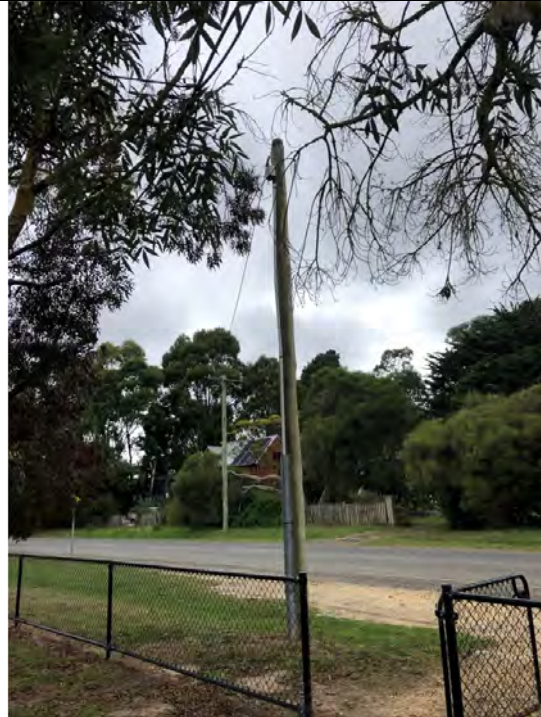
Figure 3- Existing overhead supply to the Reserve MSB/meter panel

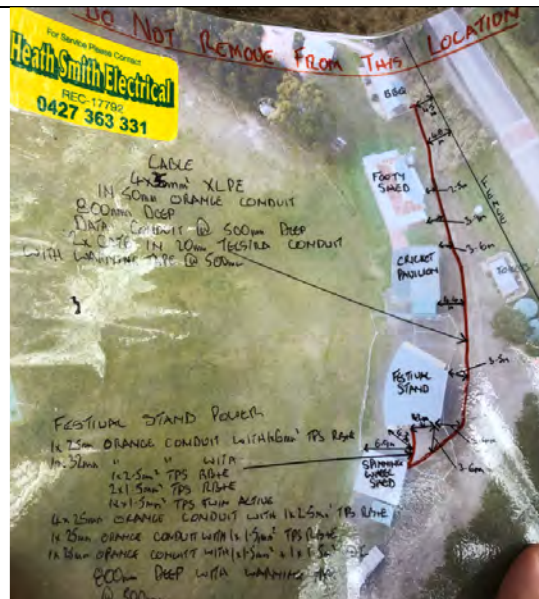
Figure 4- Recently installed electrical & comms infrastructure reticulation on site

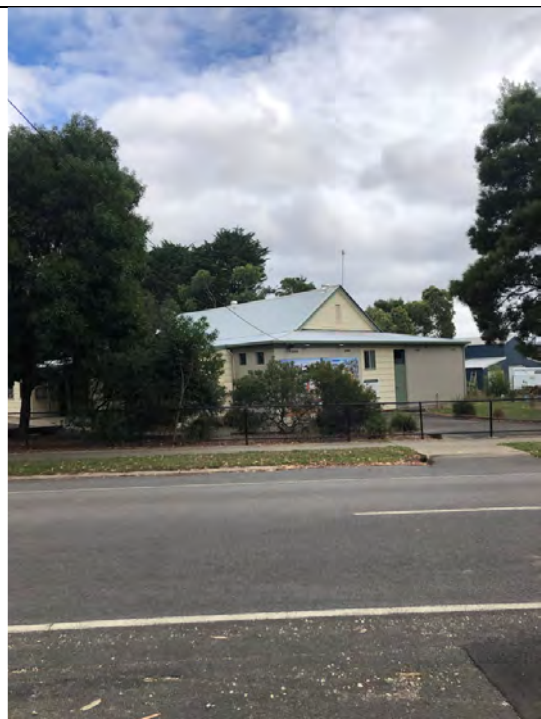
Figure 5- Existing overhead supply to the Hall from Pennyroyal Valley Road

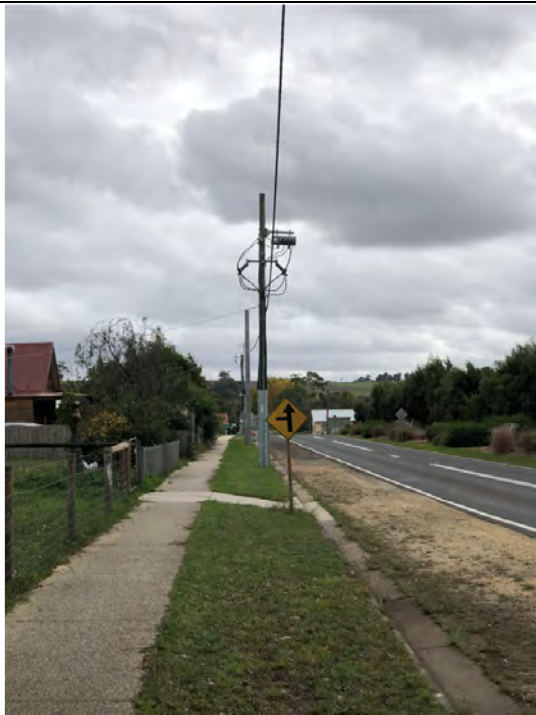
Figure 6- Nearest overhead HV service on Winchelsea-Deans Marsh Road

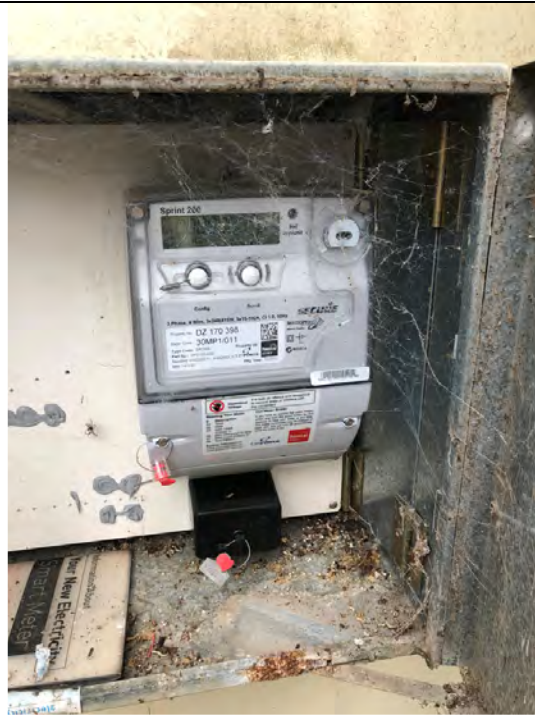
Figure 7- Existing meter panel located on the Community Hall facility

There are no electrical services or infrastructure that would be proposed to be retained or reused in any redevelopment of the Community Hall. The age and condition of the majority of services appear to be relatively old and in average to poor condition. The current switchboard is not provided with individual RCD protection to lighting and power circuits

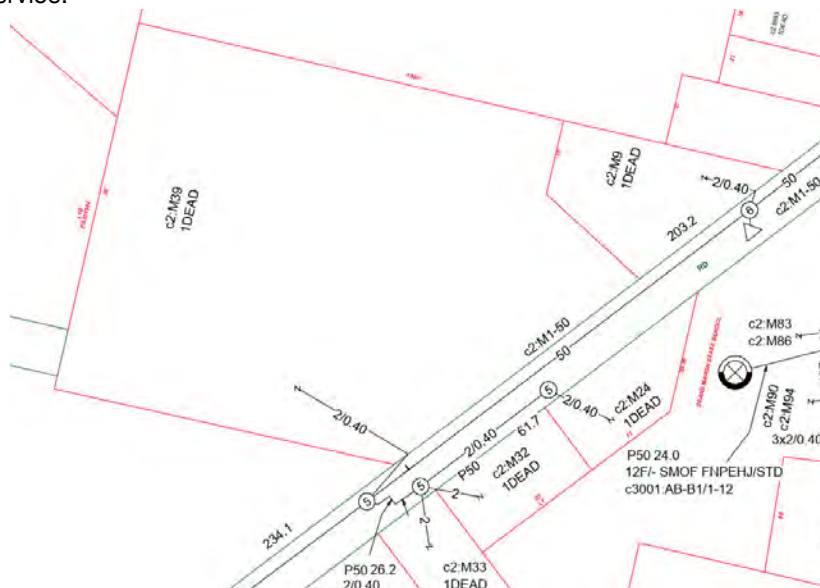
The Authority communications infrastructure is provided in Pennyroyal Valley Road from a service pit on the boundary. However it appears that the site appears to have a relatively new fixed wireless NBNCo service to a communications rack within the childcare facility. In any redevelopment of the facility, it would appear that an NBNCo connection will be via a fixed wireless service.

Figure 8- Telstra Communications service in Pennyroyal Valley Road

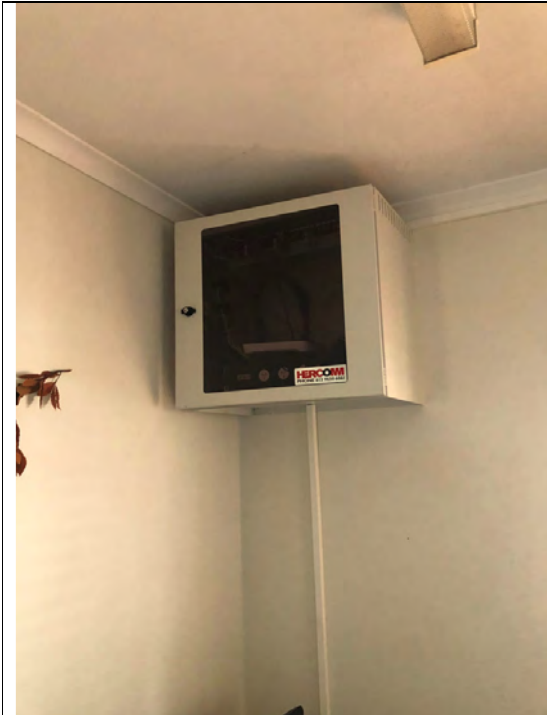
Figure 9- Comms rack located in MCH area of Community facility

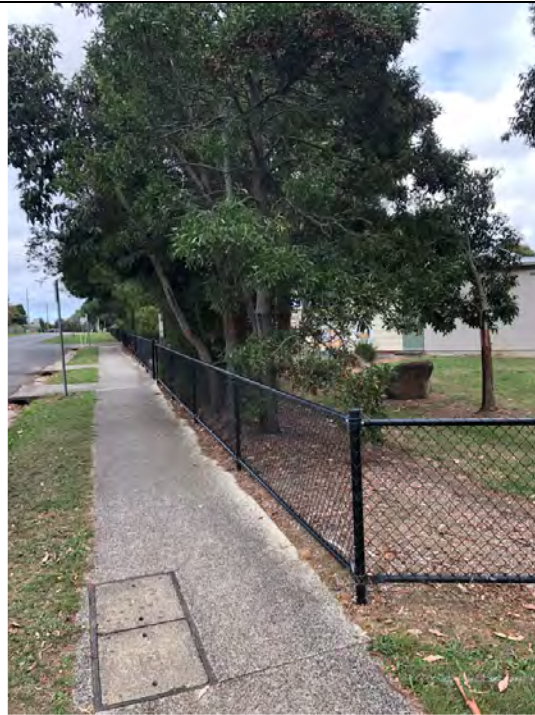
Figure 10- Existing Telstra/NBN pits located in the property boundary in NE corner of the site.

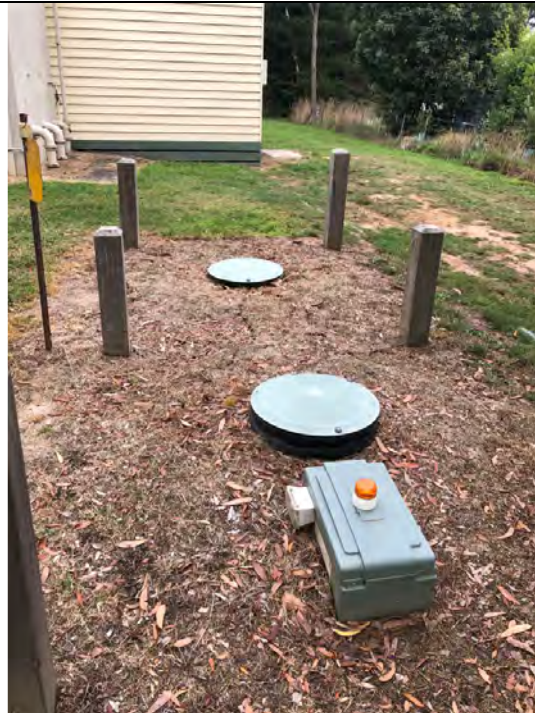
The system consists of two inground tanks, both 3200 litres in capacity, with a four step treatment process with disinfection and disposal in the final stage. It could not be determined where the current disposal area or process is, but it is assumed that the reserve has a sub surface irrigation system or absorption bed for the system. The system is noted as having capacity for treatment of 1500 litres or 10 equivalent persons.

Figure 12- Wastewater treatment system with in ground storage/treatment tanks

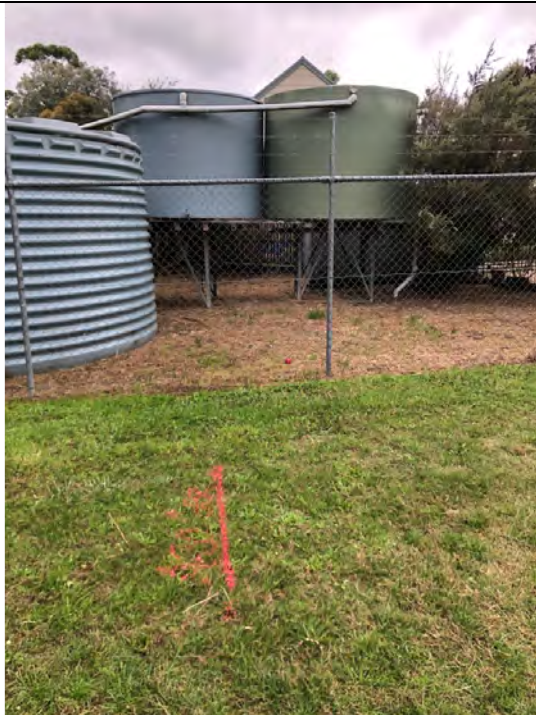
Figure 13- Onsite rainwater tank farm at rear of the site

The collection and treatment of rainwater for the proposed facility will be required from the roof area. The collection capacity would need to be determined with building use and available roof collection area. An onsite treatment and pressure pump system would be proposed for the site.

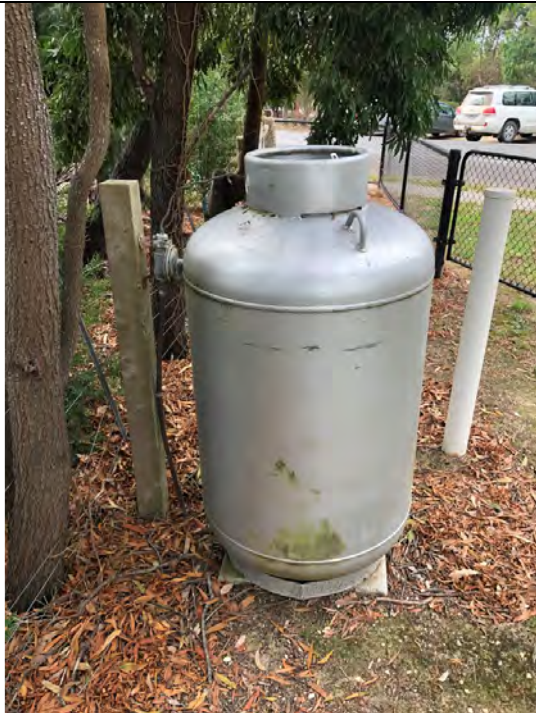
Figure 15- Onsite LP gas storage tank

In any redevelopment of the site, the requirement for gas will need to be determined, with the potential for gas use, primarily for the commercial kitchen area. The requirement for gas or no gas on site will impact on the required electrical load and infrastructure required for the site.

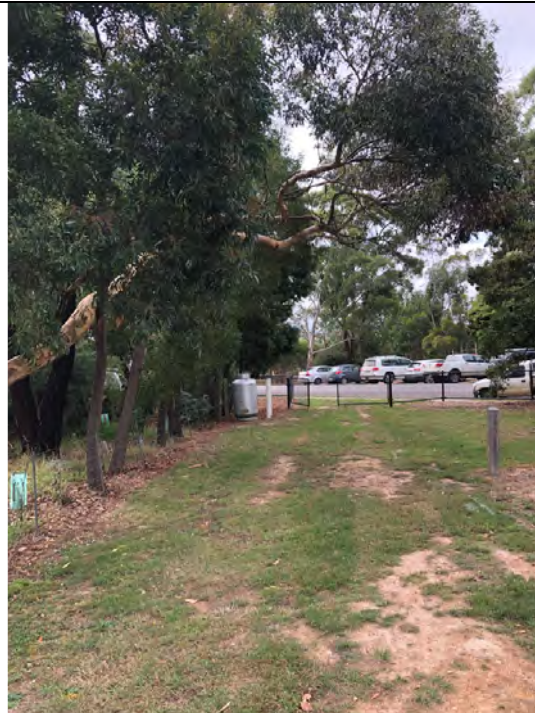
Figure 16- LP Gas tank located in NE corner of site

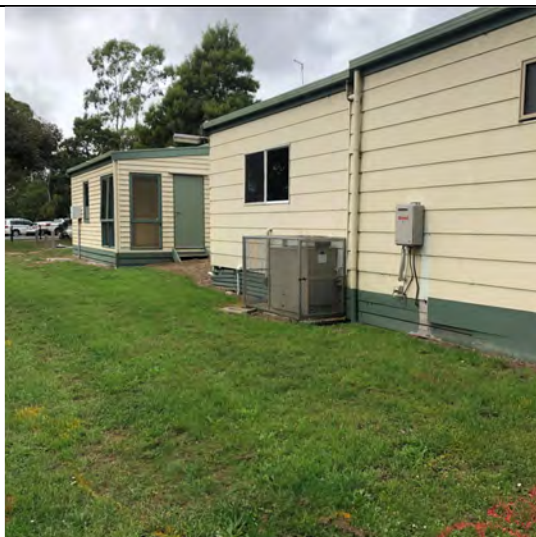
The gas appears to be serving an existing gas furnace system and an instantaneous gas hot water system.

Figure 17- Gas heating furnace & DHW unit located on north façade

The existing gas instantaneous unit appears to be in average condition, however, no date on the installation of the system could be determined. The requirement for gas domestic hot water in any redevelopment would need to be considered with the requirement for gas to be provided to the site at all. The option for an efficient electric heatpump hot water system should be considered with the ability to offset the power requirements, in lieu of gas.

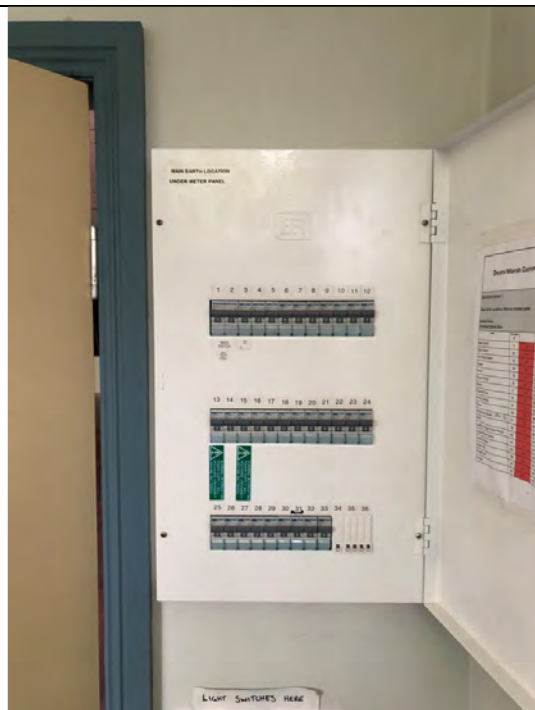
Figure 18- MSB located in Community Hall

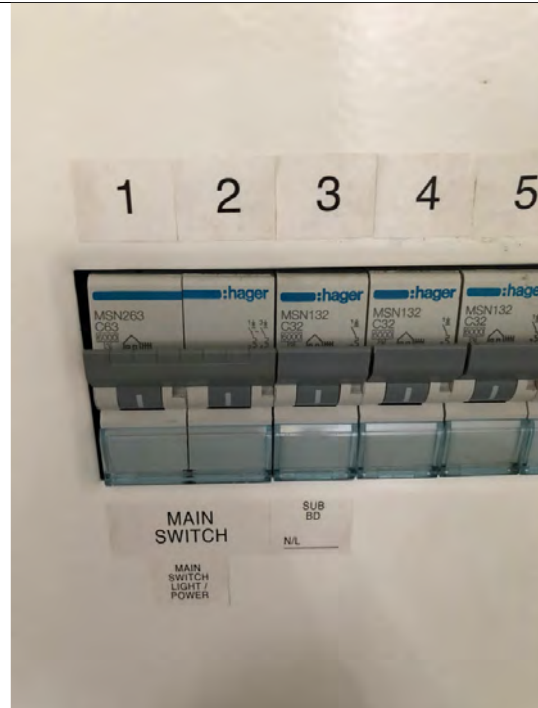
Figure 20- Two phase main switch & circuits not provided RCD protection

In any refurbishment of the existing facility, it would be recommended that the majority of services be upgraded, replaced and brought up to current regulations and requirements.

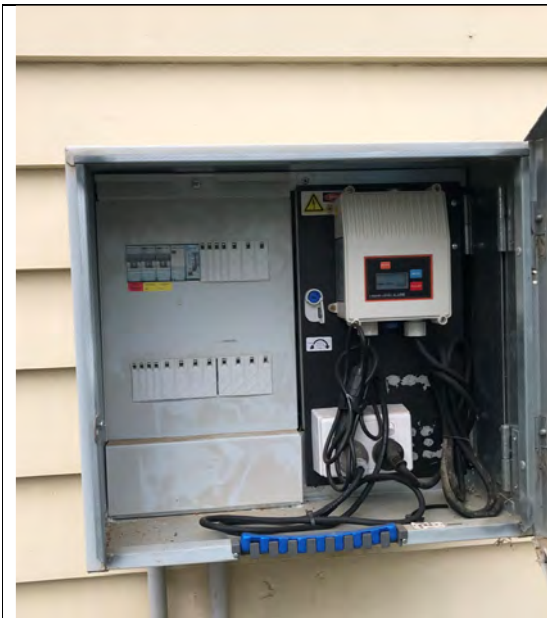
Figure 21- Wastewater Treatment system control panel

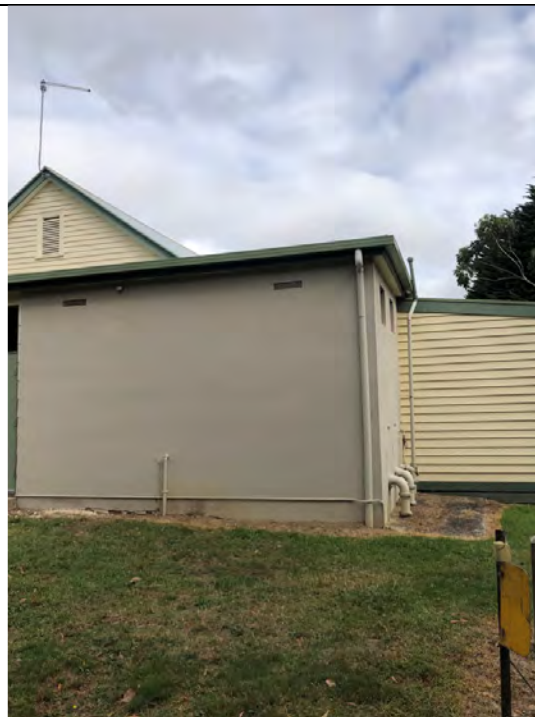
Figure 22- Sewer reticulation from local amenities adjacent the wastewater treatment system in NE corner of site

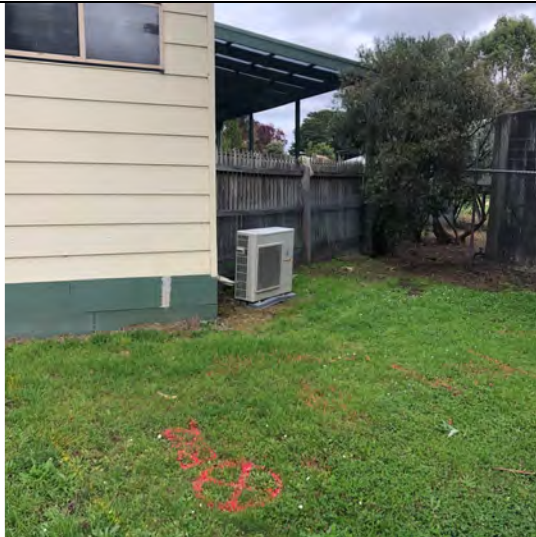
The site is served by a number of single split reverse cycle air conditioning systems. The systems appear to be of varying condition and age and serve the habitable rooms within the current facility. It is unclear if the existing gas furnace is still operational and/or utilised in the function of the facility.

Figure 23- Condenser unit located on ground at rear of the building

In any redevelopment of the site, it would be proposed to provide new reverse cycle air conditioning throughout the facility to suit the size and capacity required for the noted habitable areas. The potential for a central multi-head variable refrigerant flow (VRF) type system would be considered for such facilities, with the system providing an energy efficient heating and cooling solution.

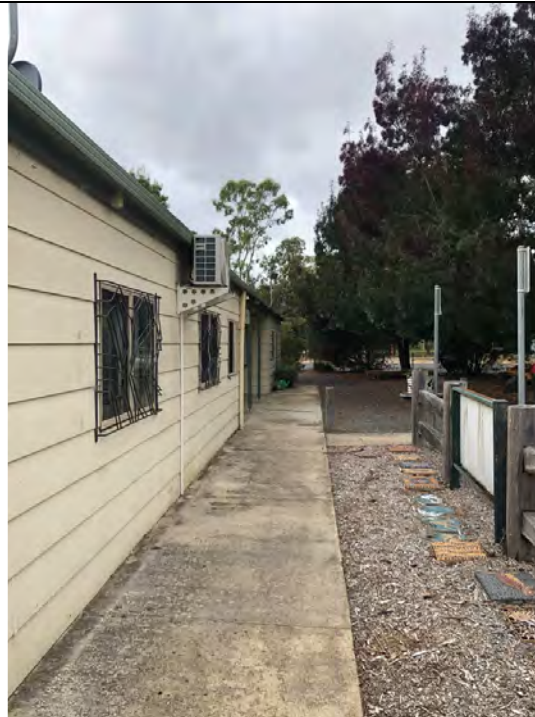
Figure 24- Condensing unit located on façade bracket at high level, installed in 2021

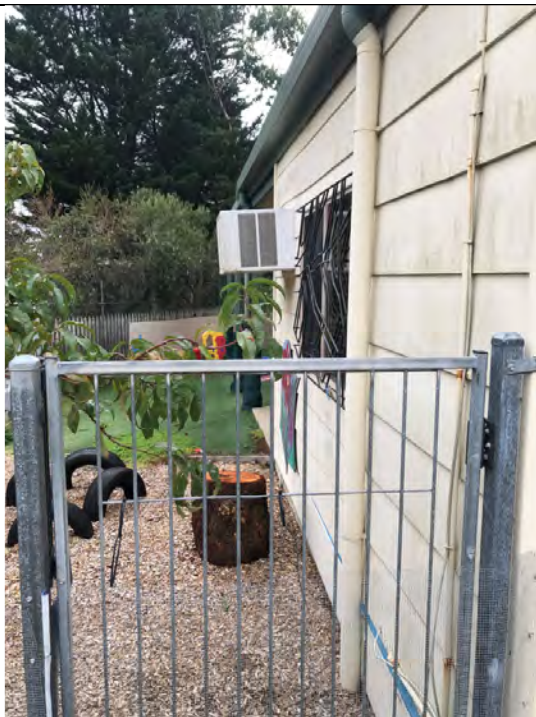
Figure 25- Room A/C unit located in childcare area at rear of the facility

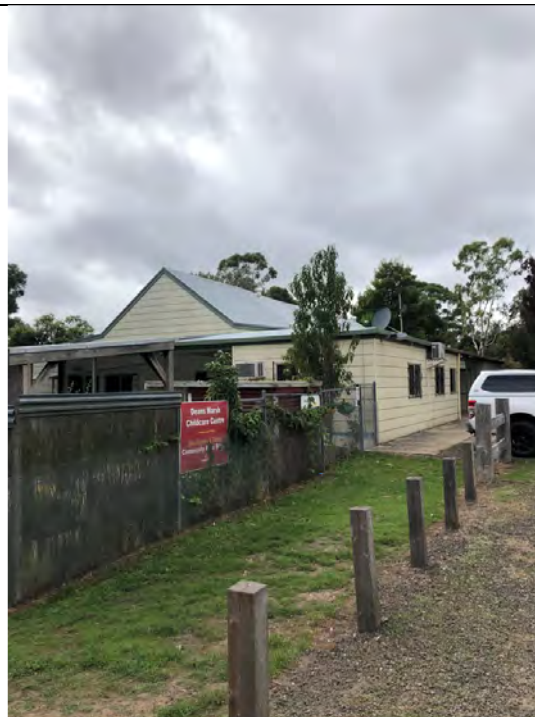
Figure 26- NBNC fixed wireless receiver located at roof level

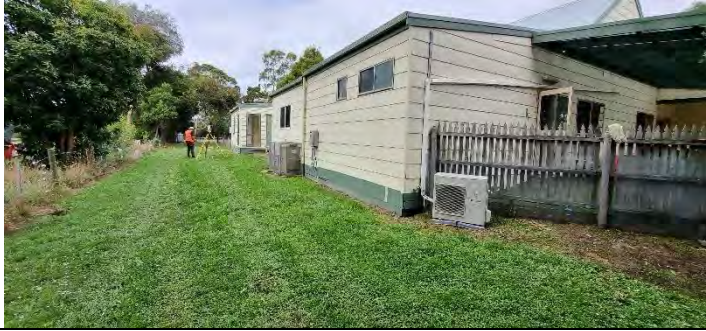
Site conditions – Facing east, photo along the north face of the community building

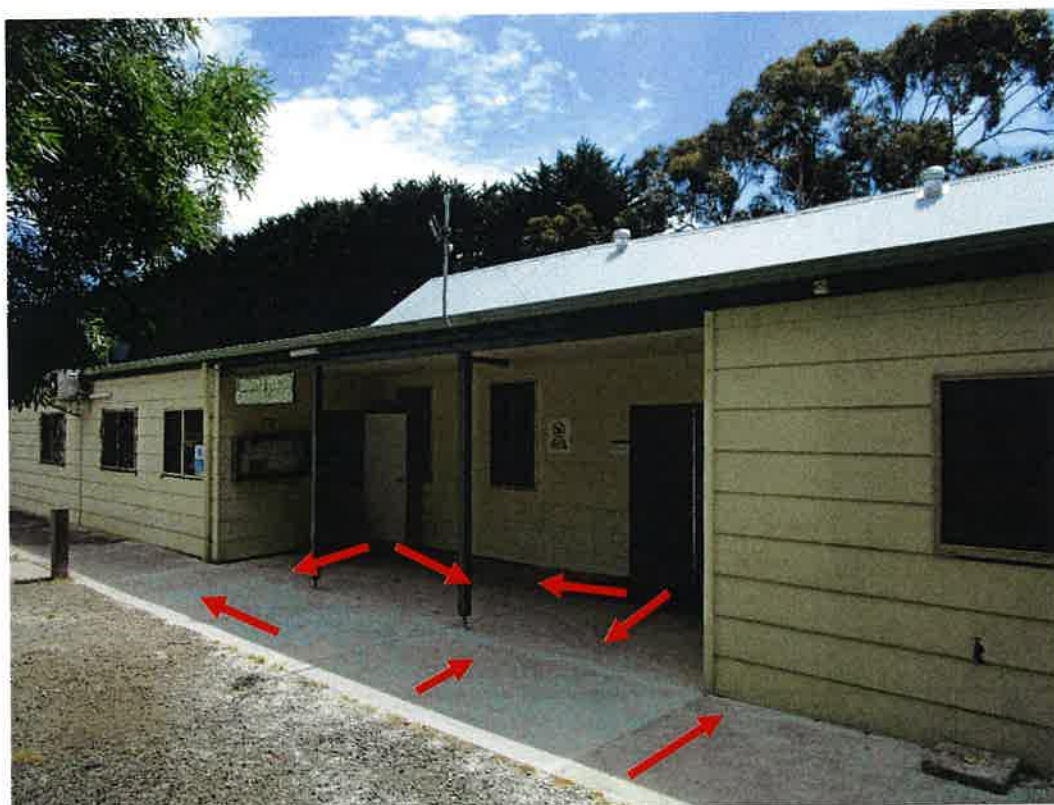
Photo 2; South of hall. Arrows show direction of paving fall.

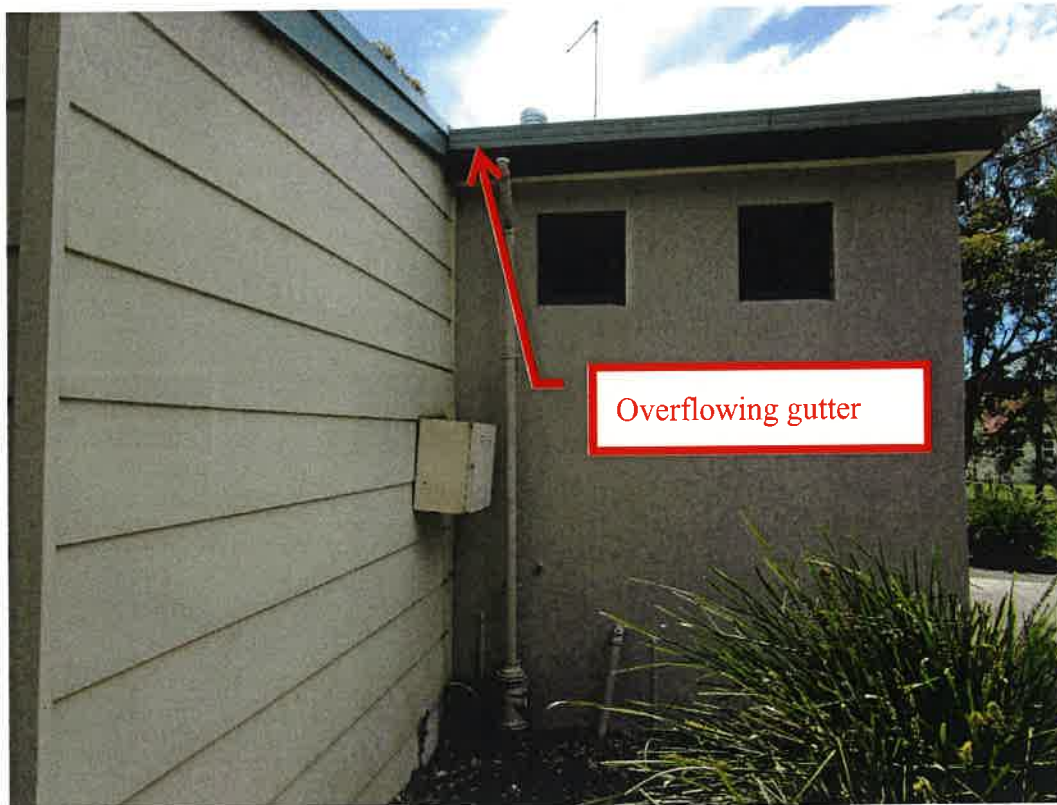
**Photo 3; Building south east re-entrant corner.**

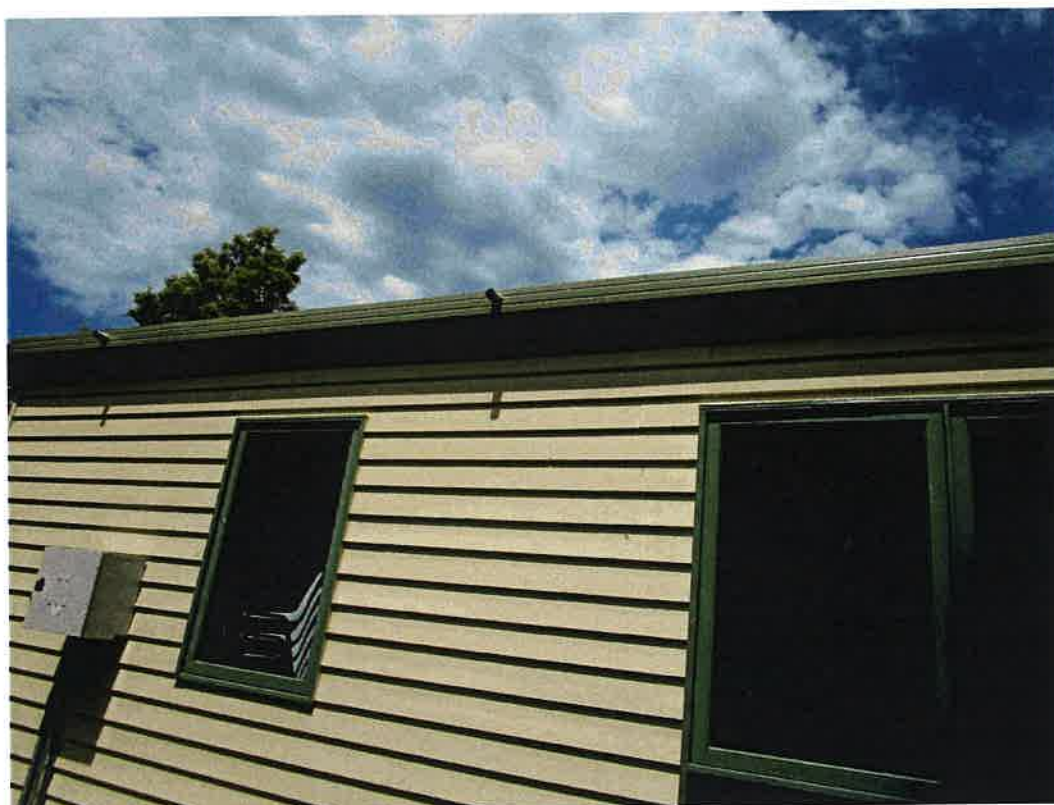
**Photo 6; North gutter showing overflow outlets.**

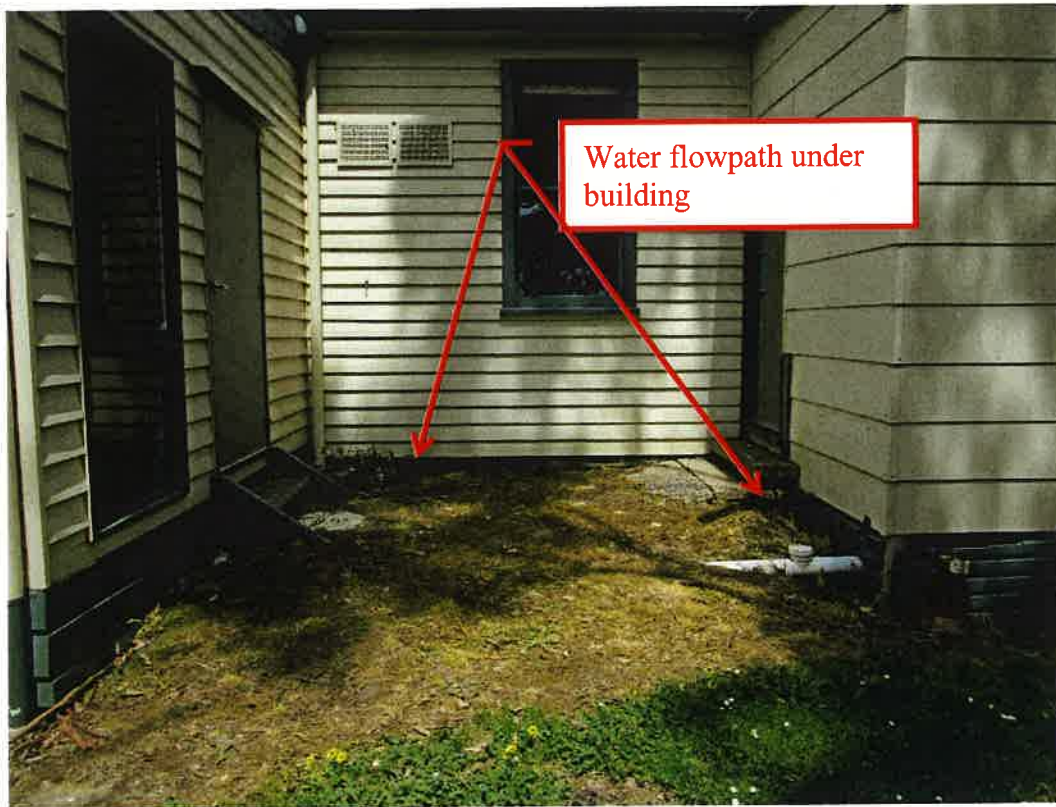
**Photo 7; North courtyard; soil surface level higher than under building.**

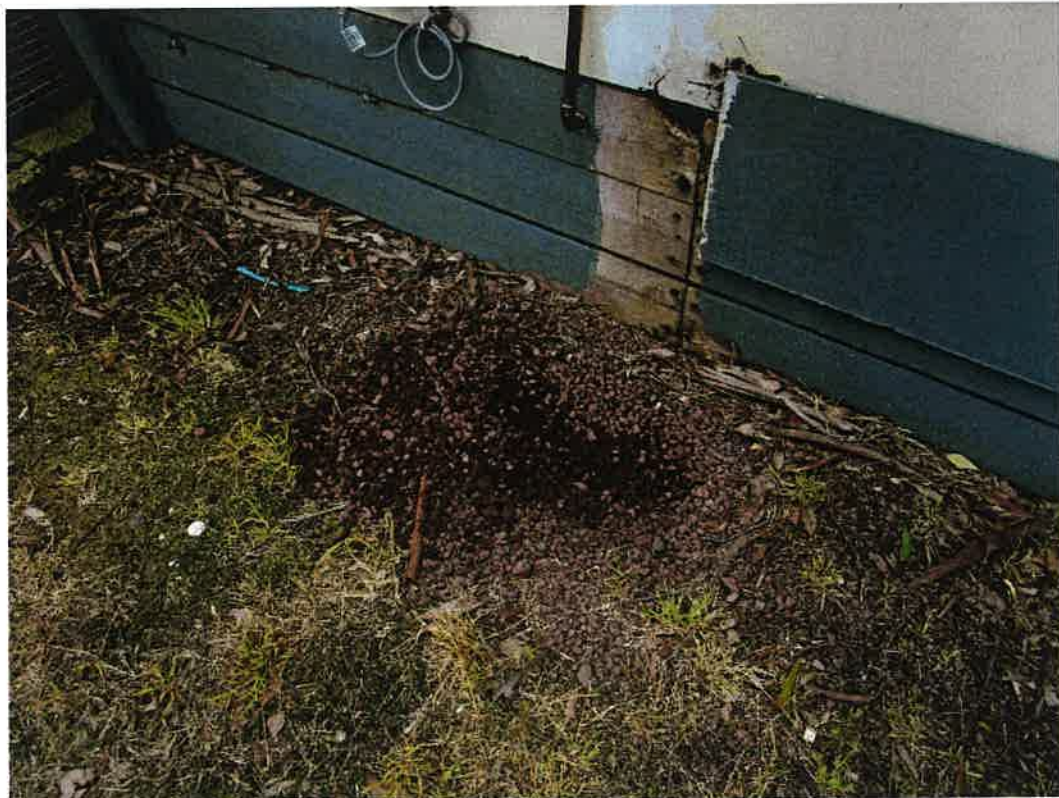
**Photo 8; North side. Scoria filled hole. Purpose unknown.**

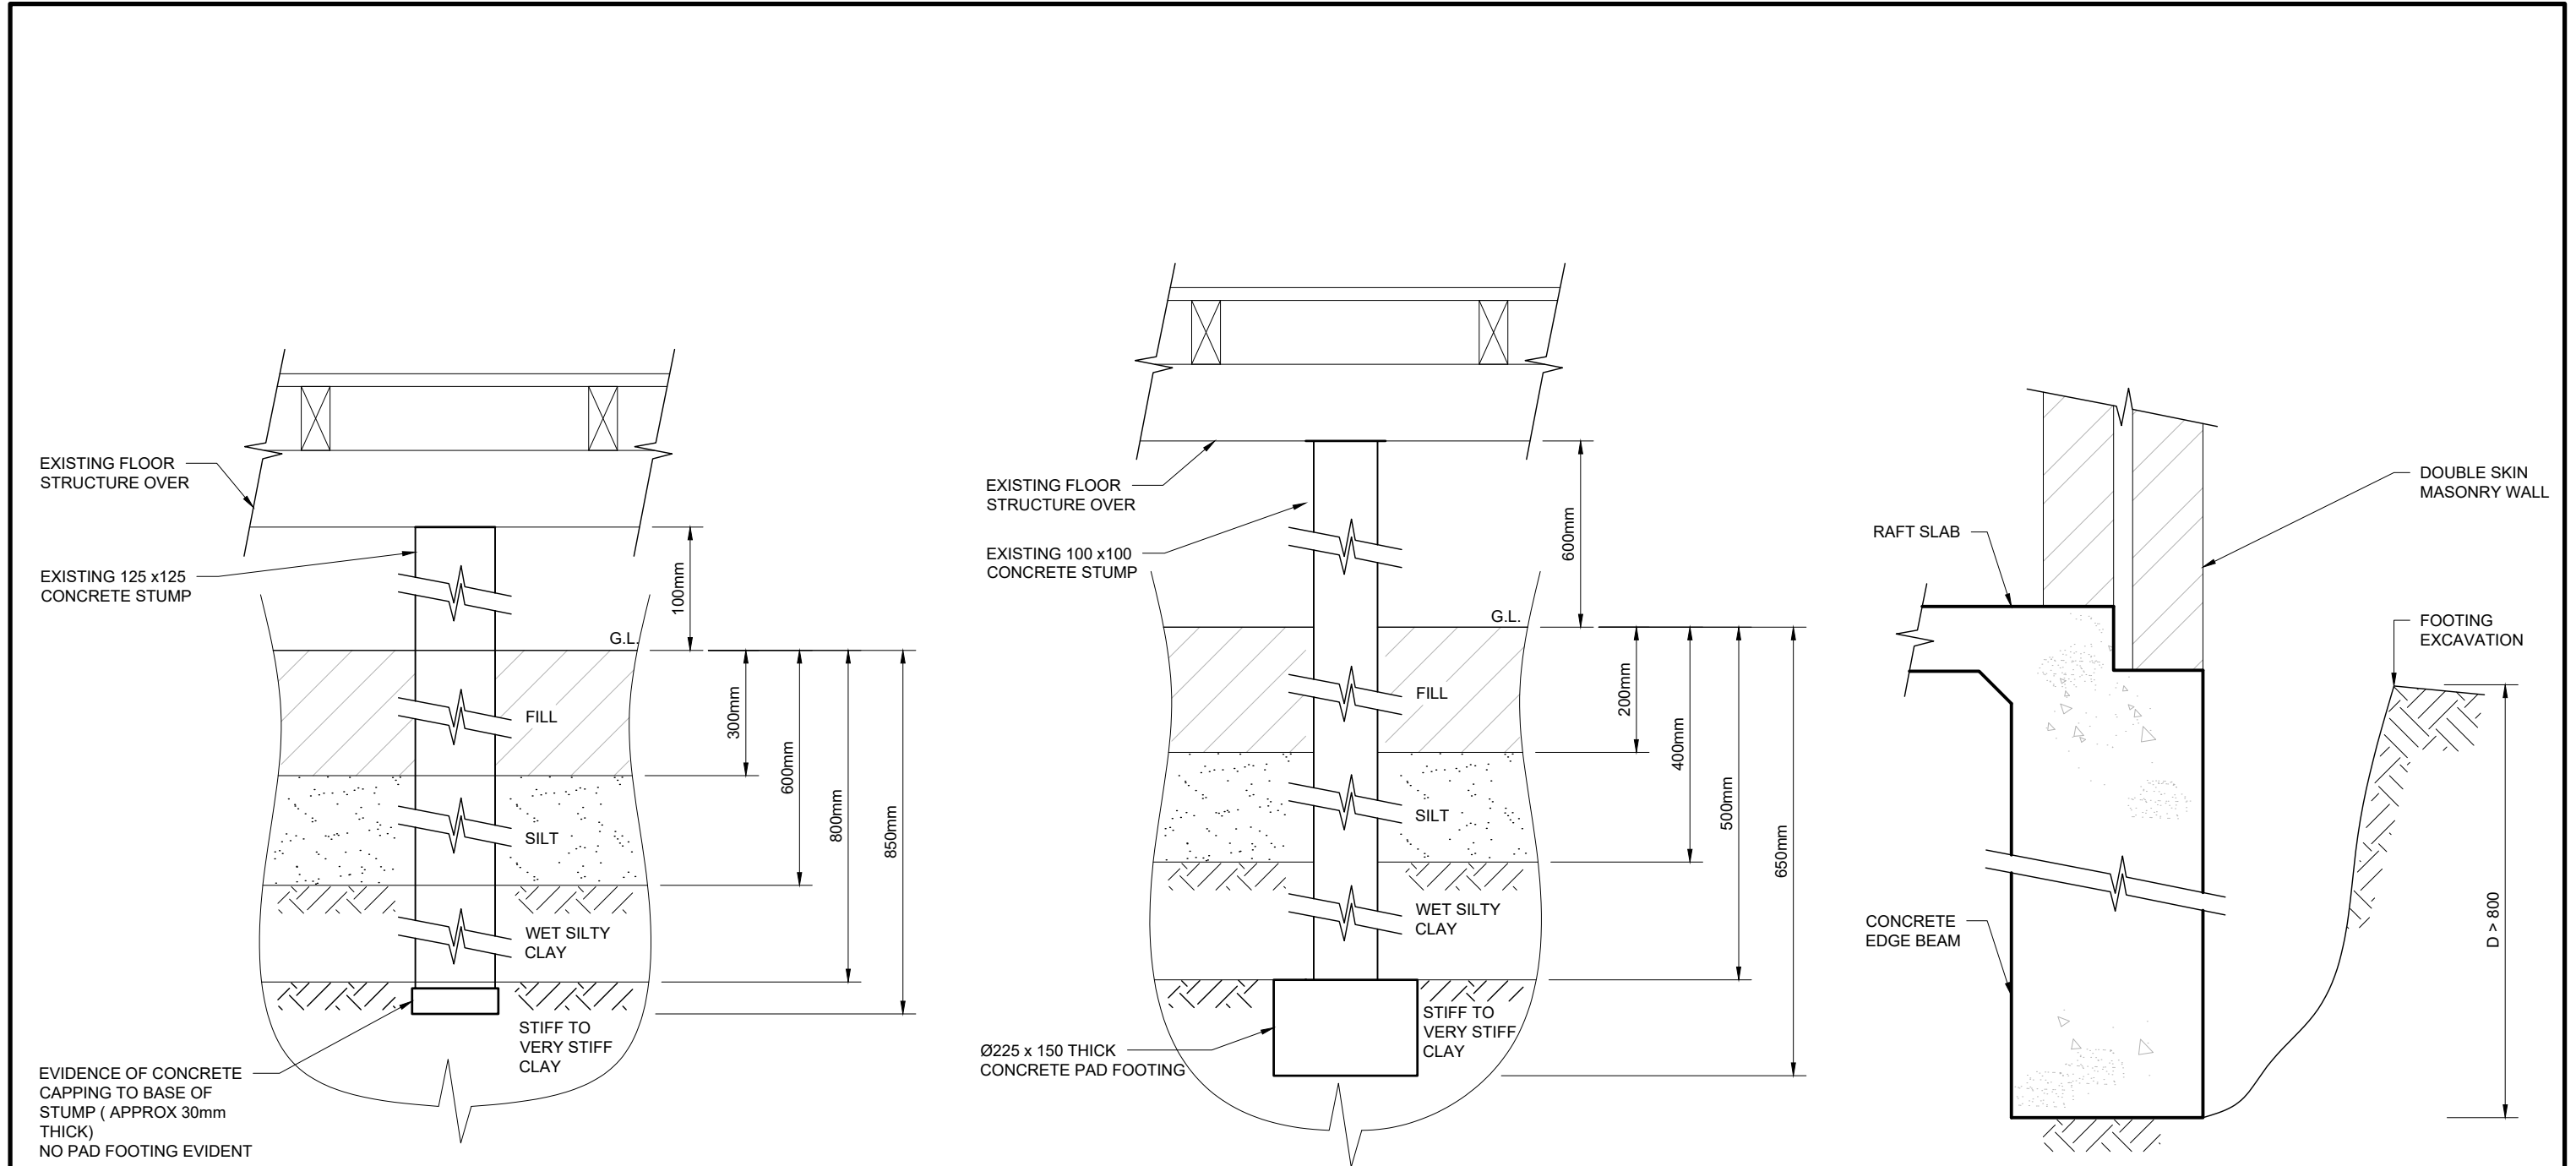
FOOTING EXPOSURE 1

Two footing exposures were completed on the northern perimeter (Drawing 23688\_F09). Stumps were founded 650-850 below ground level. No pad footing was evident at footing exposure 1 and a small pad footing (Ø225x150 thick) was evident at footing exposure 2. Footings were founded 30-150mm into stiff to very stiff clay with overlying soft fill/silt/silty clay. Founding material was wet (Photo 10 & 12).

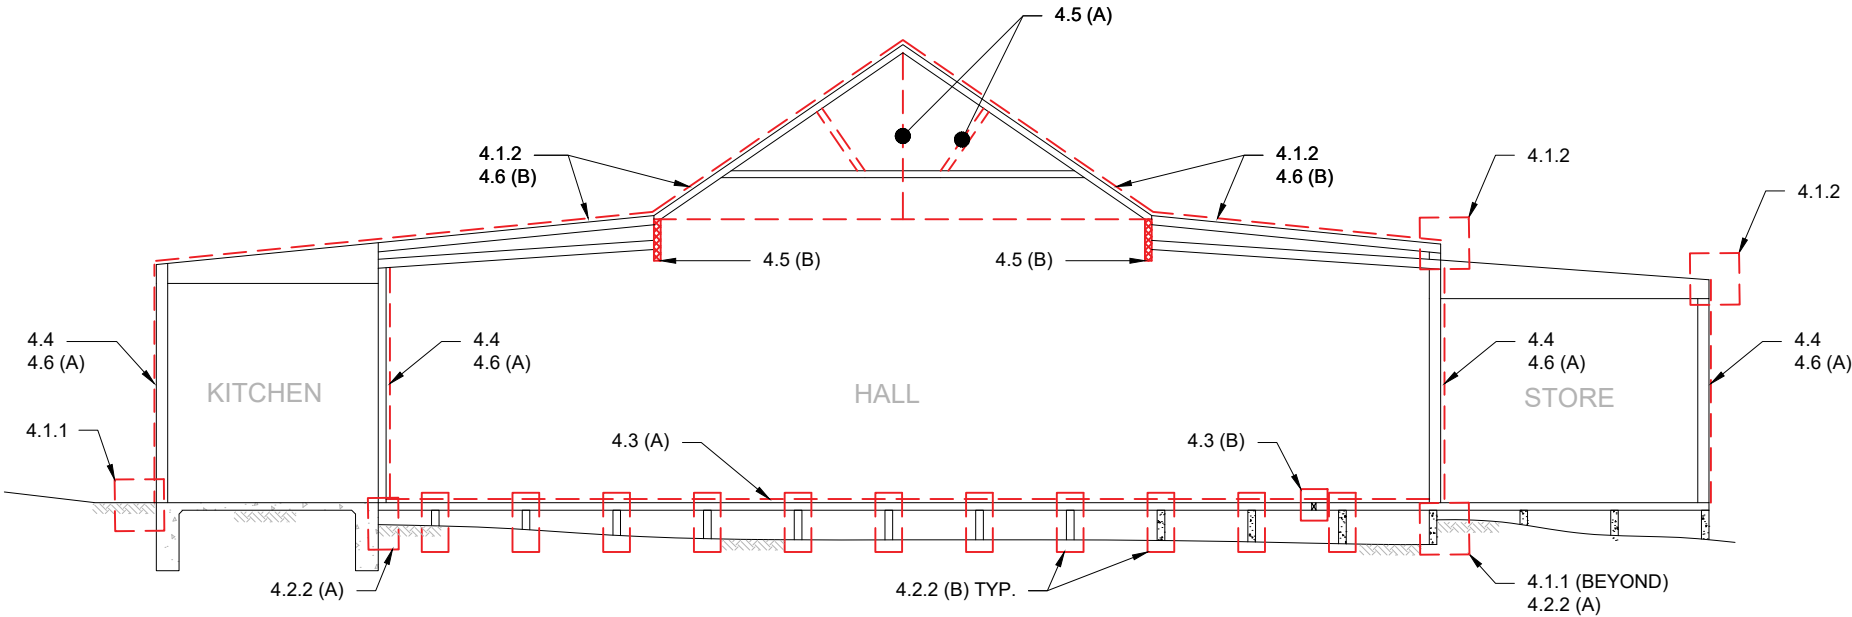
TYPICAL BUILDING CROSS SECTION 1:100

The overall tilt of the building is likely caused by swelling of the reactive clays on the uphill side and shrinkage on the relatively drier downhill side. Swelling founding material in response to a build-up of moisture under the footings is common on the uphill side of buildings where surface and subsurface runoff first reach the building and founding material. This is compounded by the presence of rafts slabs and paving which create a naturally humid subfloor environment. This may also be further compounded by leaking roof drainage (Photo 04). The drier subfloor environment created by timber floors and the drying effect of trees causes shrinkage of reactive clay founding material.

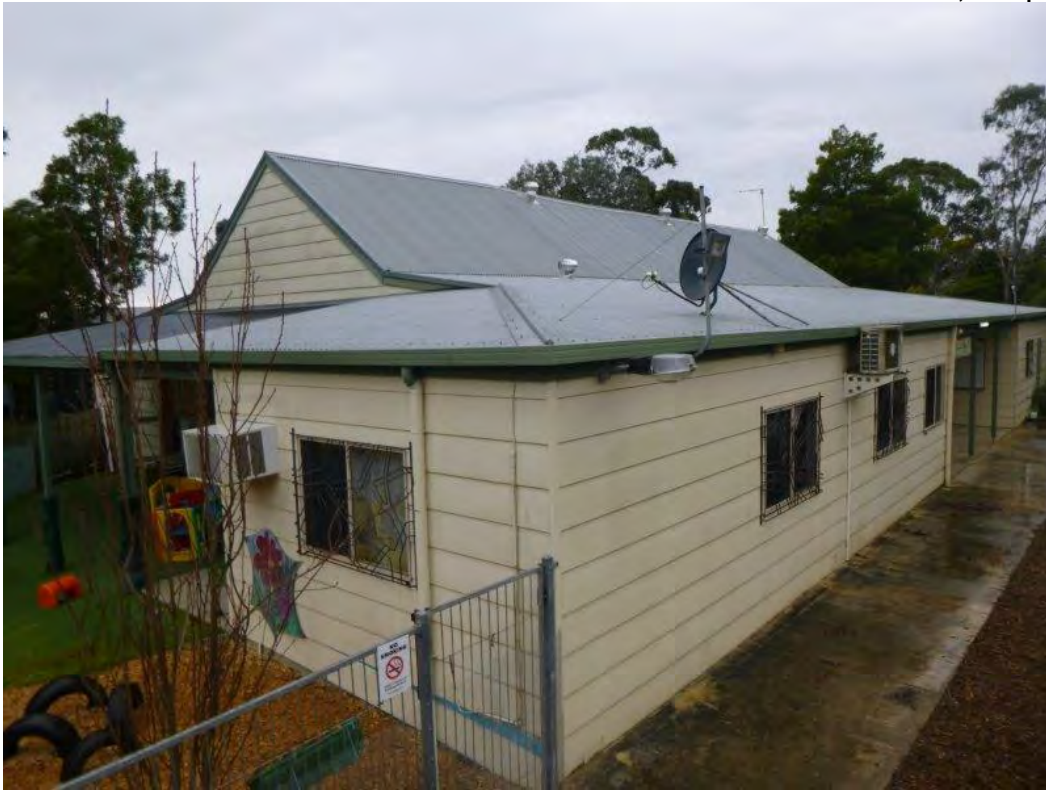
Photo 01 - External.jpg

The external levels to the majority of the western perimeter were raised close to floor level with little or no subfloor clearance (with synthetic grass surface to childcare outdoor play area – Photo 18). The south and east sides are abutted by raft slabs and paving slab with no subfloor clearance (Photo 01-06). Only the northern side had subfloor clearance and perimeter access (Photo 08, 13-15). External surface levels to a portion of the northern side had been raised (Photo 10, 35).

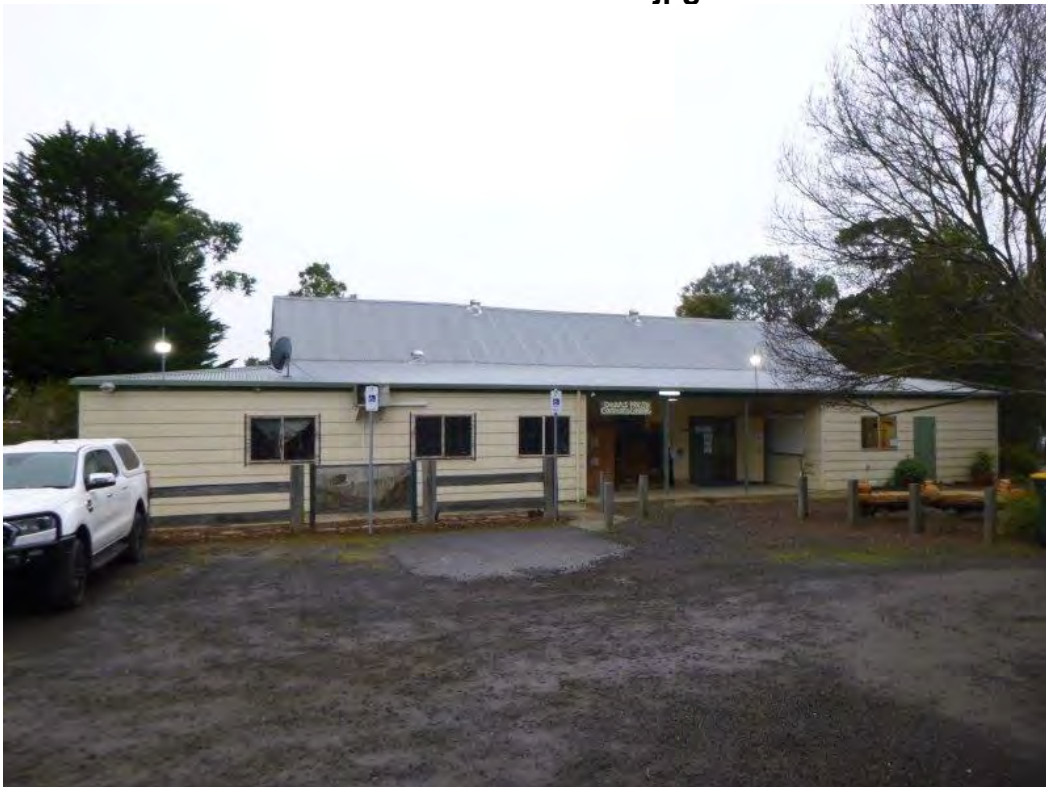
Photo 02 - External.jpg

The carparking area and uphill playground area and recreation reserve general falls towards the building with the relative low point being near the building's southern entry. There is little or no freeboard to the hall southern entry (Photo 02 & 03). Reportedly some concrete pavement works were carried out in this area to provide a localised spoon drain which it would appear directs small amounts of runoff away from the entry. However, there is no outlet or fall away from this low point. Refer to external levels in this area on Drawing 23688\_F05 in Appendix B.

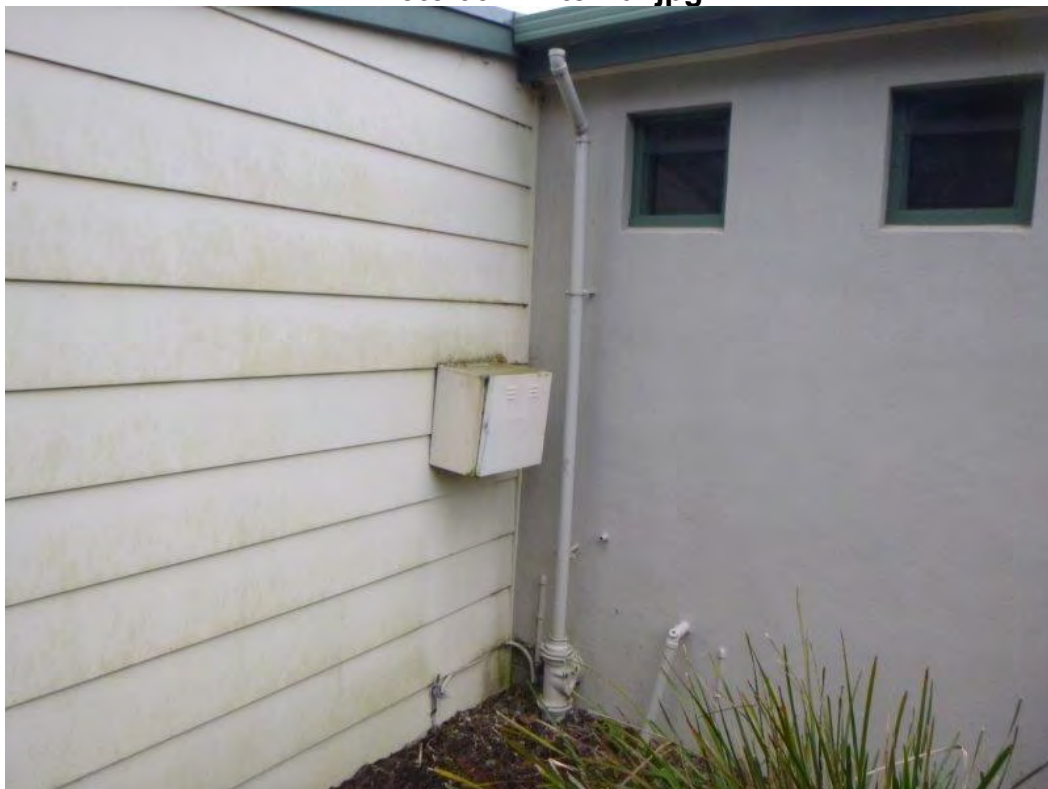
Photo 04 - External.jpg

There is generally a very slight fall away from the building on the east and southern side and better fall away on the west side. However, there are several areas around the building perimeter where water can pond (eg photo 04) and given the relative flat and marshy soils even with slight surface fall, drainage remains poor with water permeating the upper silty soils and being trapped on the underlying clay as noted in the footing exposures (Photo 10 & 12, Drawing 23688\_F09 in Appendix B). There is also likely to be subsurface flow towards the building, following the natural ground slope.

Roof seals, screw rubber seals and flashing were in fair to poor condition with many poorly constructed. Roof sheeting was corroded in places (Photo 04, 22, 25-27). Signs of water ingress were noted internally in several locations (Photo 54, 56, 59-61, 66).

It appears the gutter system to the south east corner regularly overflows, with a build up of algae and staining visible (Photo 04).
