# Facility Development Plan Issues and Opportunities

Dean's Marsh Community Hub

Surf Coast Shire

Oct 2022 REV 2

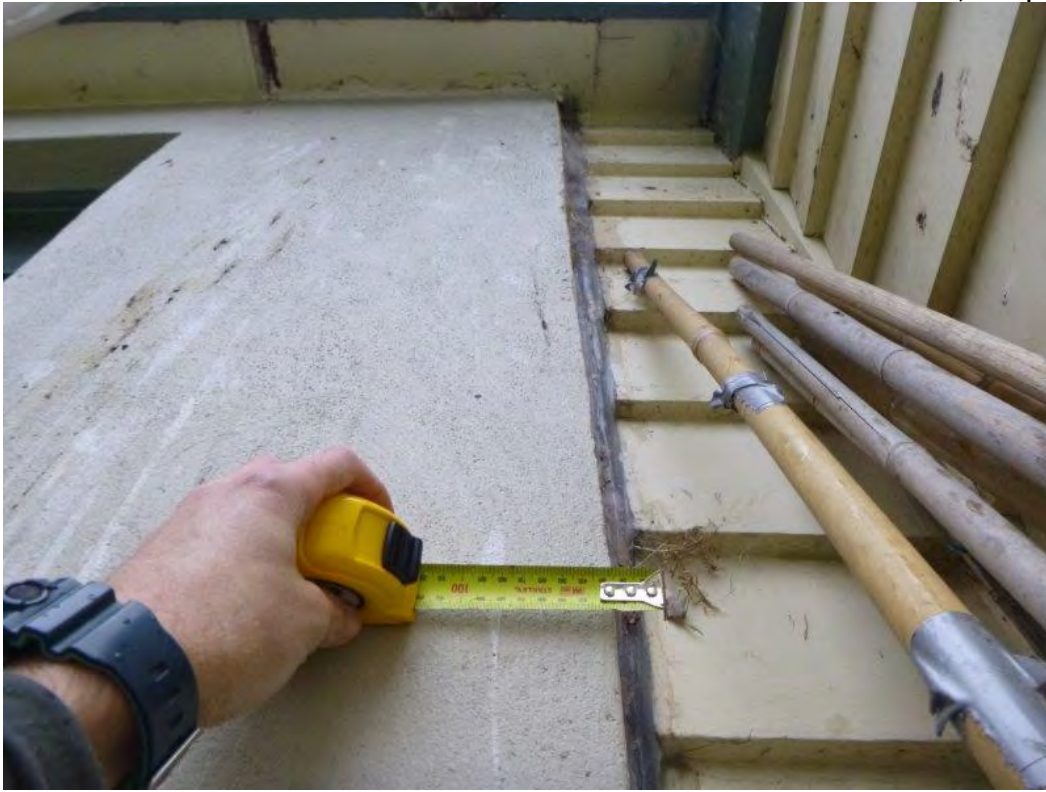
Photo 07 - External.jpg

There is some isolated brickwork cracking to the eastern toilets (reported as circa 1975, previously reported as circa 1999) and there is differential movement visible at the northern junction with adjacent hall building on stumps (Photo 07, 55, 56). Similar damage was noted and reported by this office in 2013 (Our ref 21166 Letter dated 1 October 2013). A footing exposure was completed to the east of this area with the edge beam being in excess of 800mm deep. Up to 30mm of relative level difference was measured across the slab with the relative low point at the north east corner.

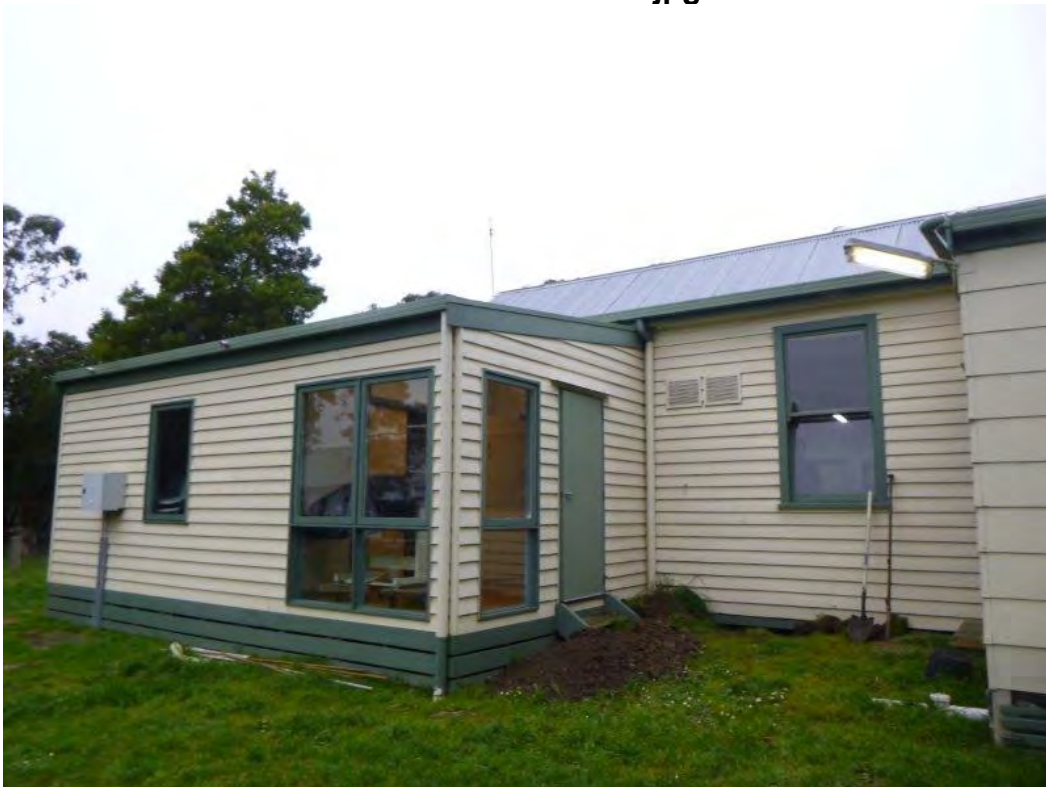
Photo 08 - External.jpg

Gutters on the northern side were falling away from the downpipe outlet, with water ponding in the gutter. Several overflow pops had been retrofitted further reducing the capacity of the gutters, with uncontrolled overflow contributing to the site drainage issues around the building perimeter (Photo 08, 23, 24, 26).

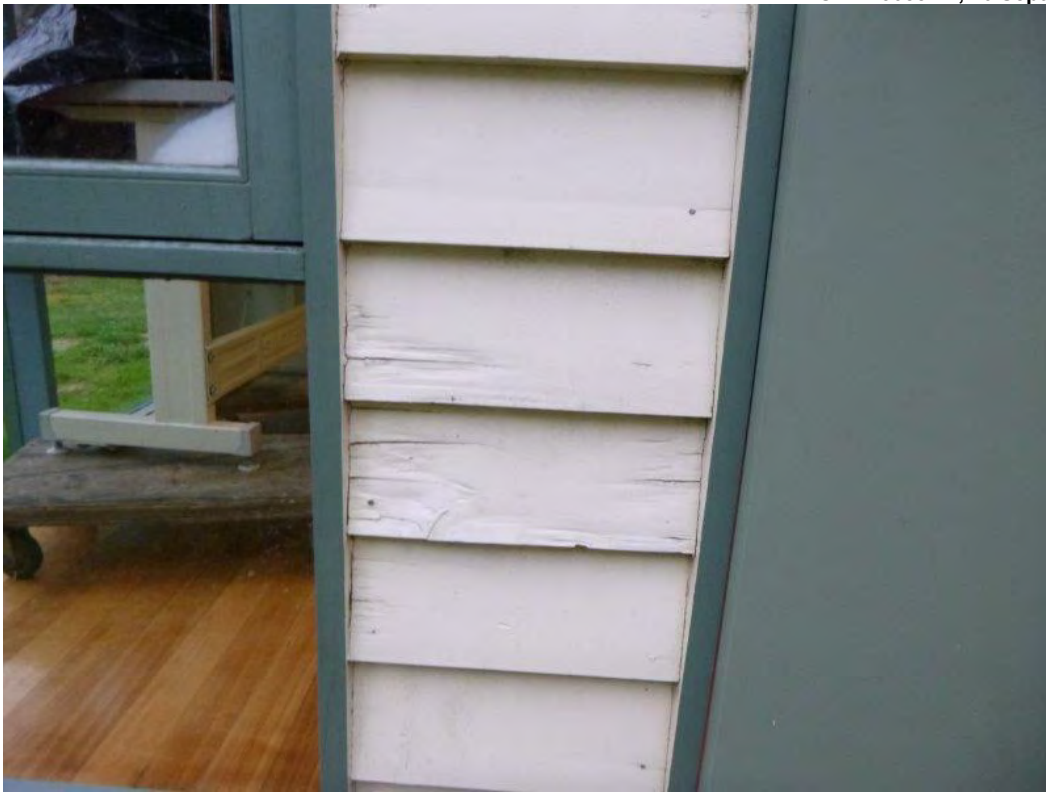
Photo 09 - External.jpg

Wall cladding varied in material, style and age around the building. The external cladding was mostly fibre cement weatherboard with some traditional timber weatherboard to the southern side. Refer to external photos in Appendix C for further details and extents. Some localised damage and rot were evident in some locations (Photo 09, 15, 19).

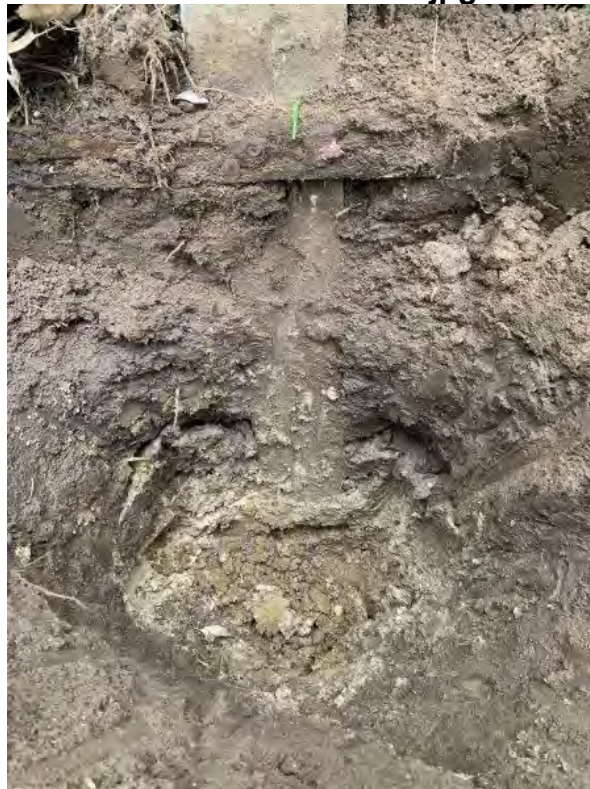
Photo 10 - External.jpg

The external levels to the majority of the western perimeter were raised close to floor level with little or no subfloor clearance (with synthetic grass surface to childcare outdoor play area – Photo 18). The south and east sides are abutted by raft slabs and paving slab with no subfloor clearance (Photo 01-06). Only the northern side had subfloor clearance and perimeter access (Photo 08, 13-15). External surface levels to a portion of the northern side had been raised (Photo 10, 35).

Two footing exposures were completed on the northern perimeter (Drawing 23688\_F09). Stumps were founded 650-850 below ground level. No pad footing was evident at footing exposure 1 and a small pad footing (Ø225x150 thick) was evident at footing exposure 2. Footings were founded 30-150mm into stiff to very stiff clay with overlying soft fill/silt/silty clay. Founding material was wet (Photo 10 & 12).

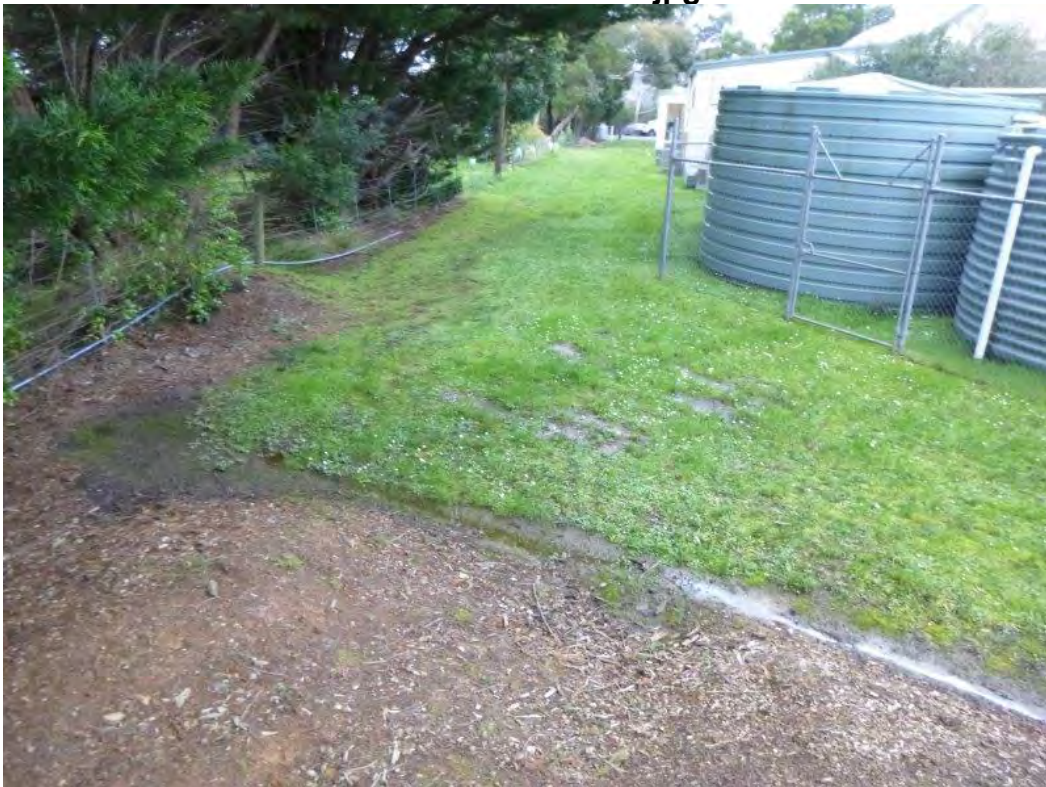
**Photo 16 - External.jpg**

There is a slight drainage depression along the northern boundary with falls towards the west. However, there is a low point to the north west of the rainwater tanks where this drainage depression and a swale from the south converge (Photo 16). Water ponds in this area until the level rises sufficiently to discharge further west. The overflow from rainwater tanks and roof drainage was not evident during site inspection and Legal Point of Discharge for stormwater was not been provided to date. It is assumed stormwater overflow discharges to this area.

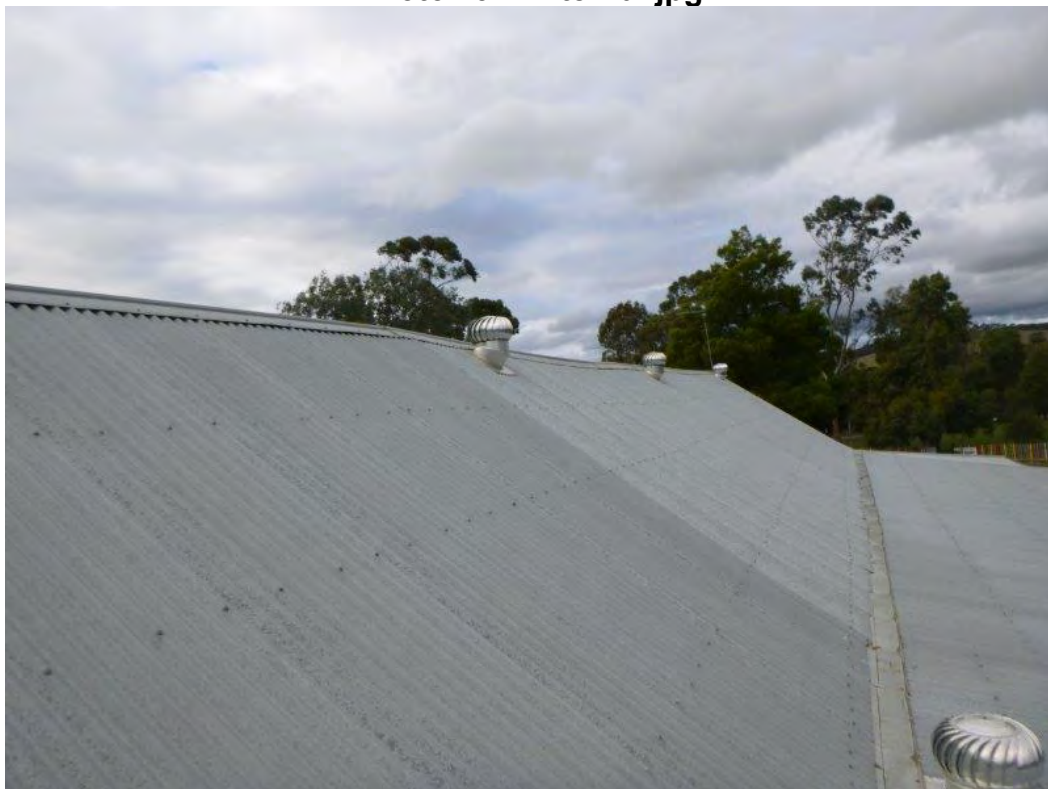
Photo 20 - External.jpg

A significant dip in the ridge vertical alignment in the area over the stage can be seen externally (Photo 20). The roof framing in this area (original hall) is framed without struts/web members to create a truss, unlike the remainder of the original pitched roof section. It was reported previously by another consultant that the struts visible elsewhere have been removed. On close inspection there were no signs of nail holes or different rafter colouration in the corresponding strut locations, commonly seen when original framing members are removed. The rafters appear to have rotated away from the ridge board. Timber cleats and packers fixed to the rafters appear to have been retrofitted to prop up roof battens and maintain pitch to roof sheeting, which presumably had deflected excessively (Photo 44, 45). The ceiling joists in this area were deflected excessively when partially loaded by a person (approximately 40-80kg).

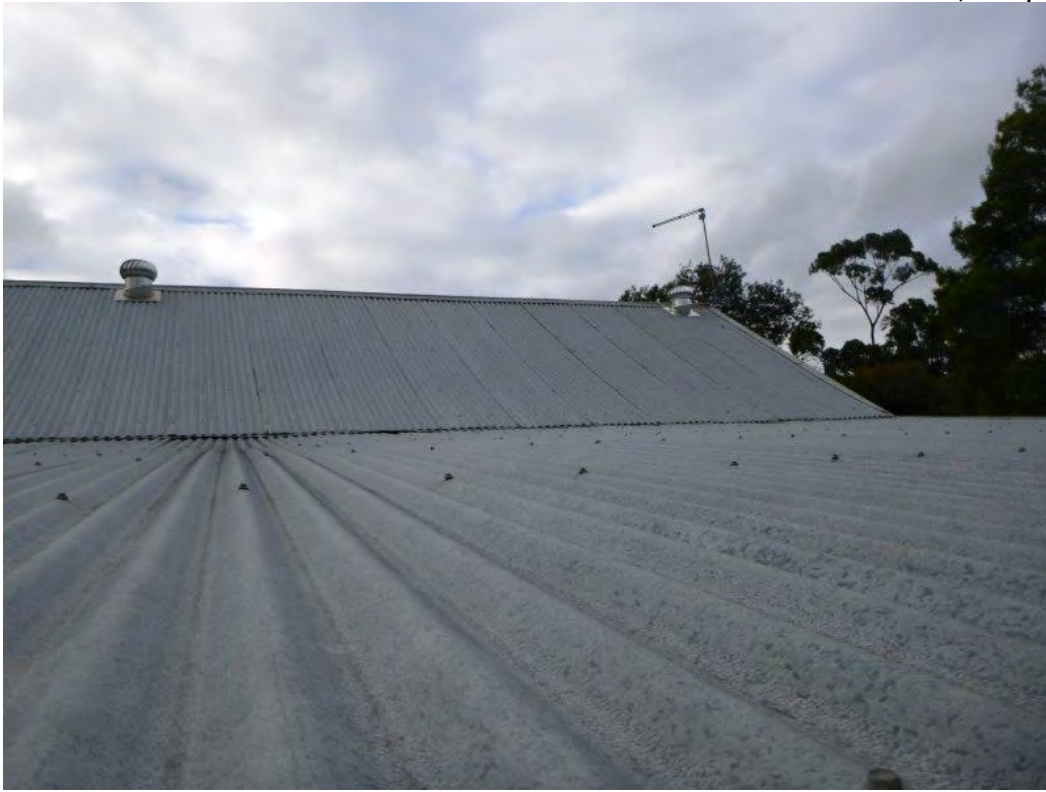
Photo 21 - External.jpg

- An excessive dip in the roof sheeting is visible externally (Photo 21). The reason for this was not explicitly clear on removal of the roof sheet, however some of the battens had signs of damage and/or defects (Photo 41). The battens were measured as approximately 70x35 on flat at approximately 900-1200 CTS;

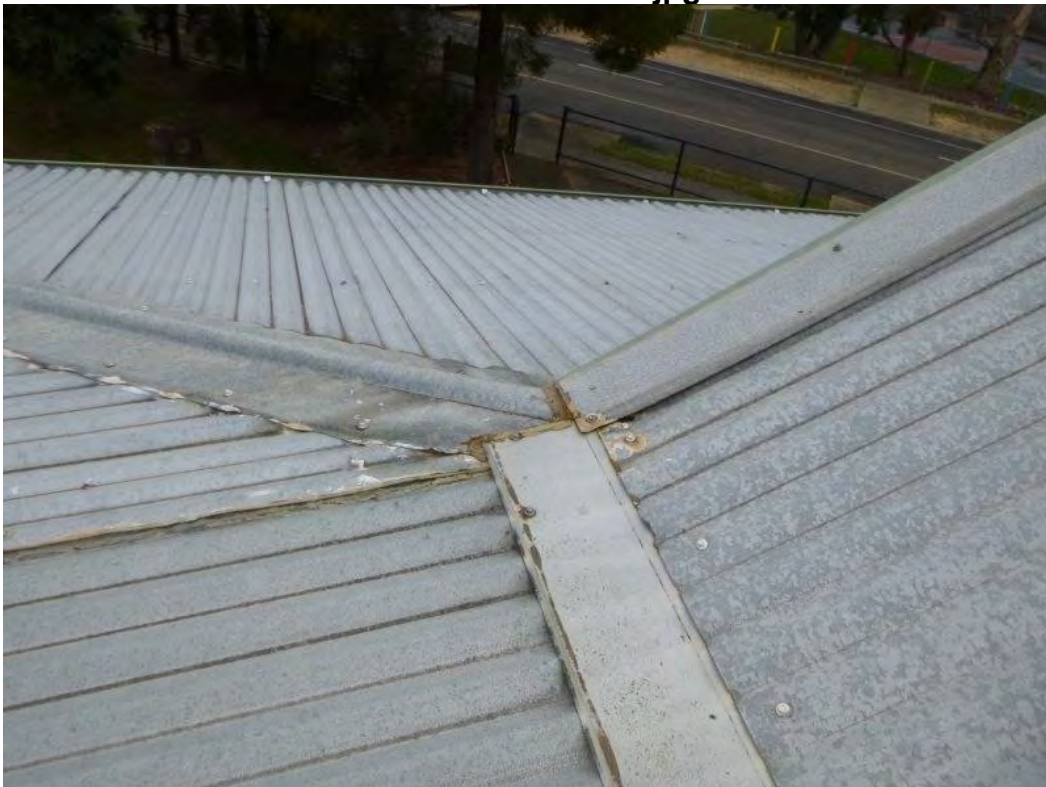
Photo 22 - External.jpg

Roof seals, screw rubber seals and flashing were in fair to poor condition with many poorly constructed. Roof sheeting was corroded in places (Photo 04, 22, 25-27). Signs of water ingress were noted internally in several locations (Photo 54, 56, 59-61, 66).

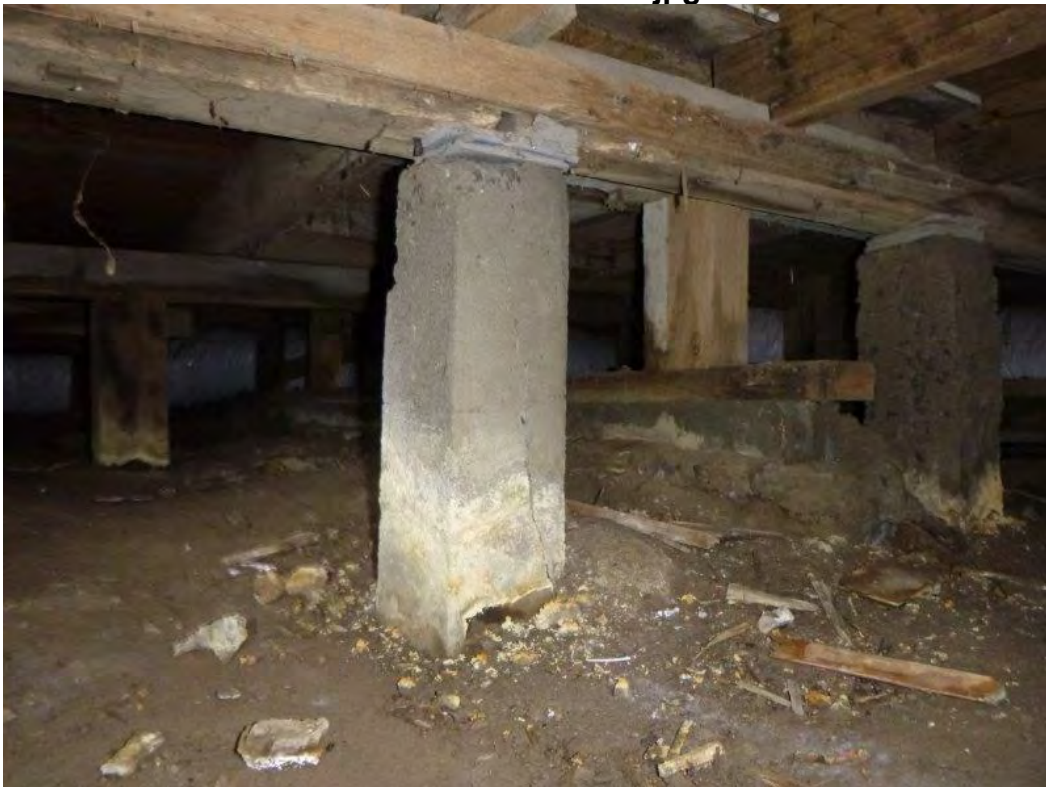
Photo 30 - Subfloor.jpg

Hardwood timber stumps were observed through the central portion of the hall (Photo 33). The northern portion of the hall and northern kitchen had concrete stumps (100-125 square). The stumps were damp to touch and efflorescence was extensive. No integrity testing was carried out on the timber stumps. Severe concrete cancer was visible in some concrete stumps with failed stumps observed in two locations (Photo 30-32, 35).

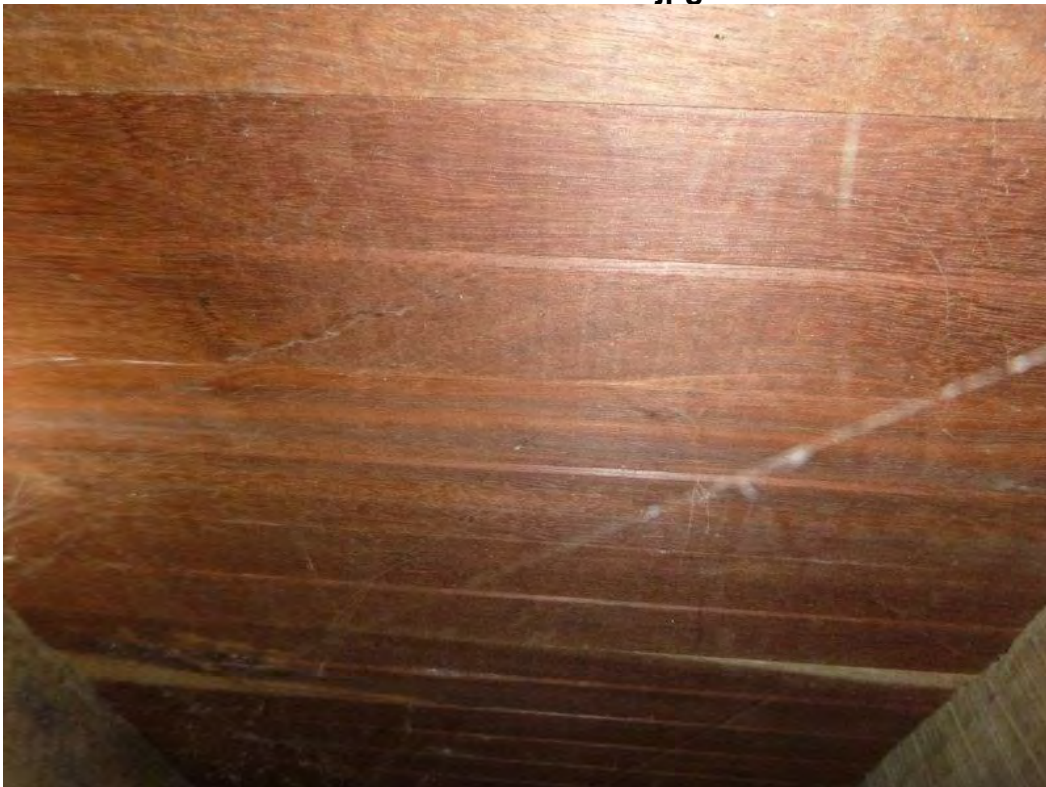
**Photo 34 - Subfloor.jpg**

The floor boards to the original hall do not appear to be original. The technology to achieve the machined edges visible from the underside would not have existed at the time the hall was originally constructed (over 130 years ago). It appears the floor boards may be tongue and grooved (Photo 34). The southern wing of the hall has different lighter coloured floor boards to the rest of the hall (Photo 50). The northern kitchen has chipboard flooring underlay with a vinyl finish.

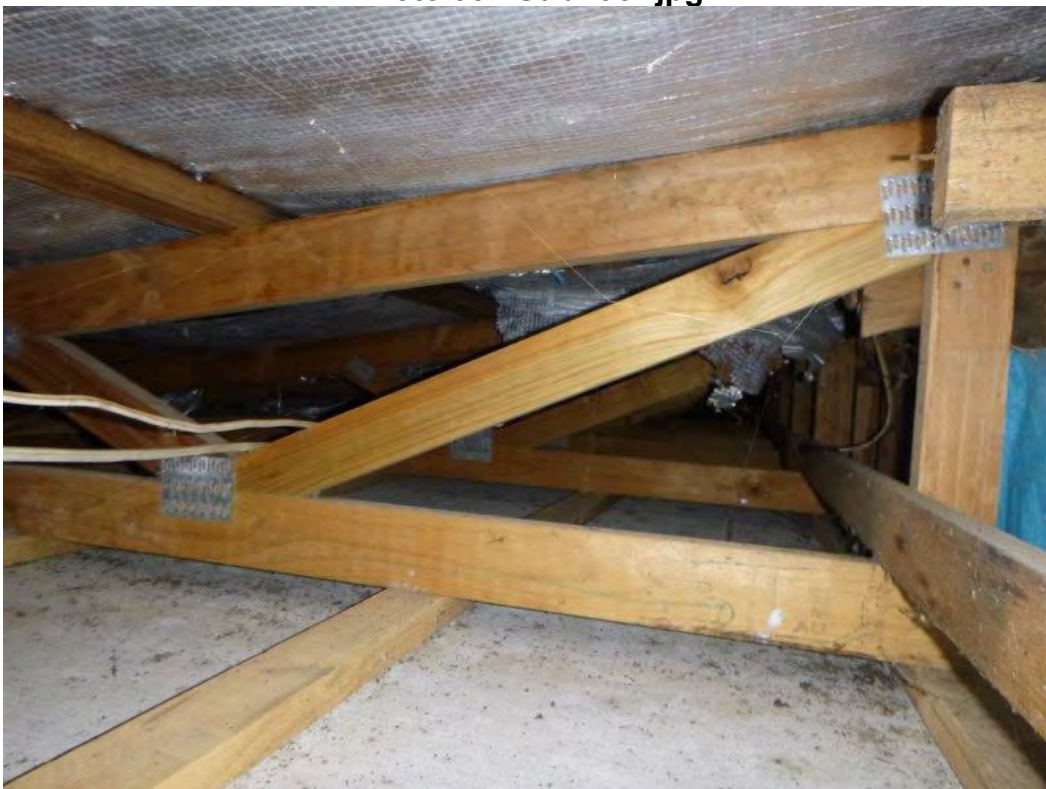
**Photo 40 - Roof Space.jpg**

- The southern kitchen roof consists of prefabricated trusses (Photo 40);
- The junction between the higher pitched roof and the “lean to” roof of the main hall is supported by a steel truss (TR1). There was rust present on much of the truss (Photo 42). Access to accurately measure the truss was limited however approximate dimensions are provided on the attached drawings. This truss spans approximately 10.5m. Columns, likely timber, are visible internally at the ends of the truss with two exposed bolt heads to the underside of the truss bulkhead. The timber panelling to the truss bulkhead appeared to be pine when viewed from the roof space;

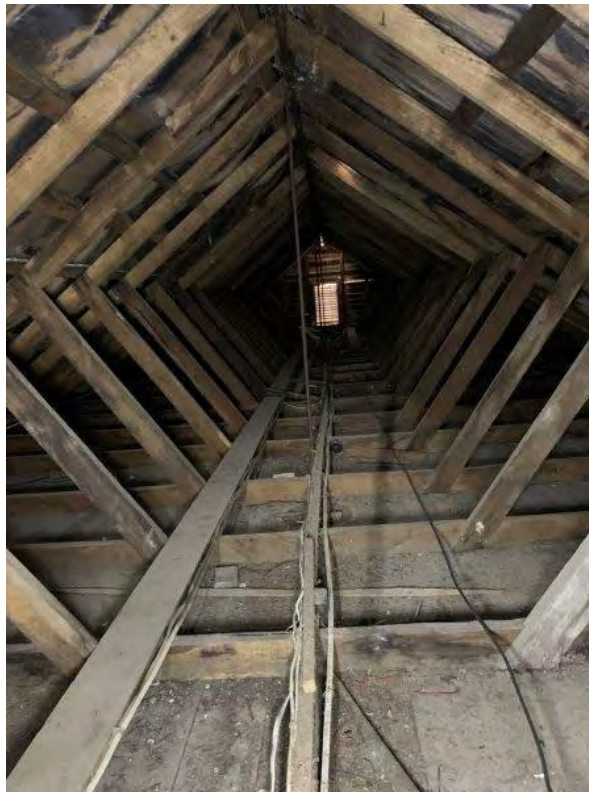
**Photo 43 - Roof Space.jpg**

The remainder of the central hall roof was framed with struts/web members to create a series of trusses. Horizontal tie rods (TB1) and vertical sag rods (SR1) between the ends of the rafters were visible at discrete locations (Photo 43). Rust was noted on vertical sag rods (SR1) within the roof space. Connections typically consisted of two nails between members.

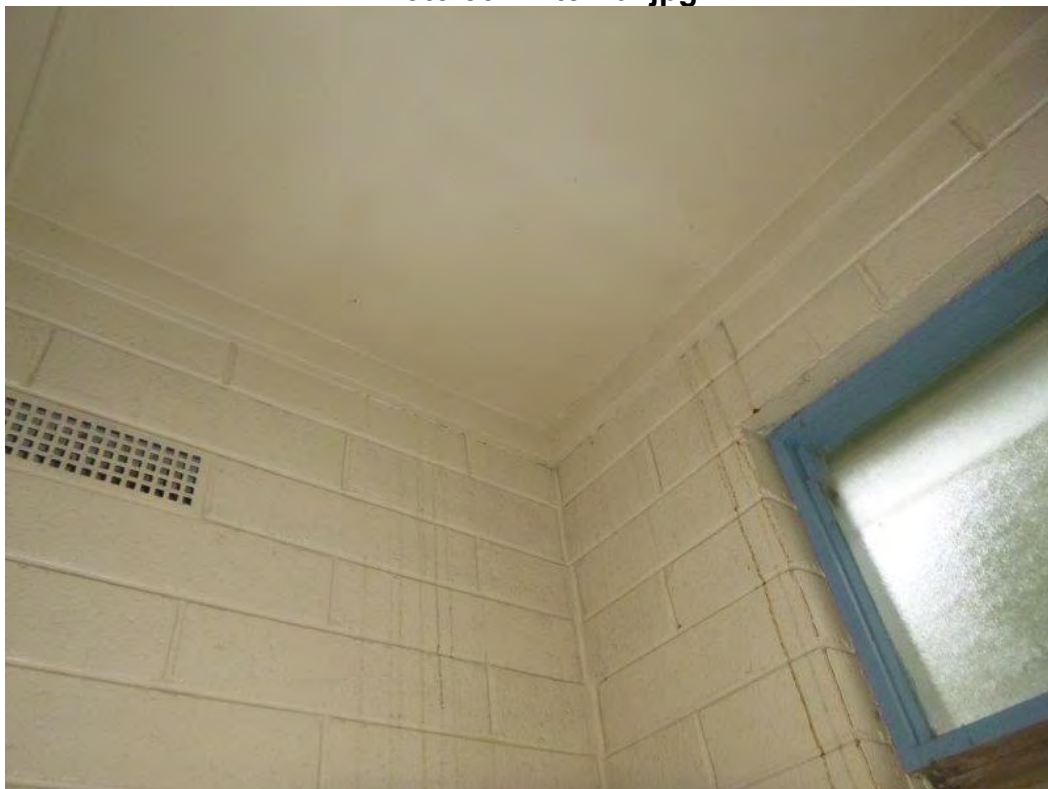
Photo 54 - Internal.jpg

Internal wall lining to the main hall area was a mixture of timber panelling (some possibly original) and plasterboard (unlikely original). Elsewhere the internal lining was typically plasterboard with exposed brickwork to the toilet area. Some minor cracking to brickwork and plaster was noted in some locations (Photo 55, 57, 58, 60, 62- 64). There were no other obvious signs of any major structural issues other than some localised signs of moisture ingress (Photo 54, 56, 59-61, 66).

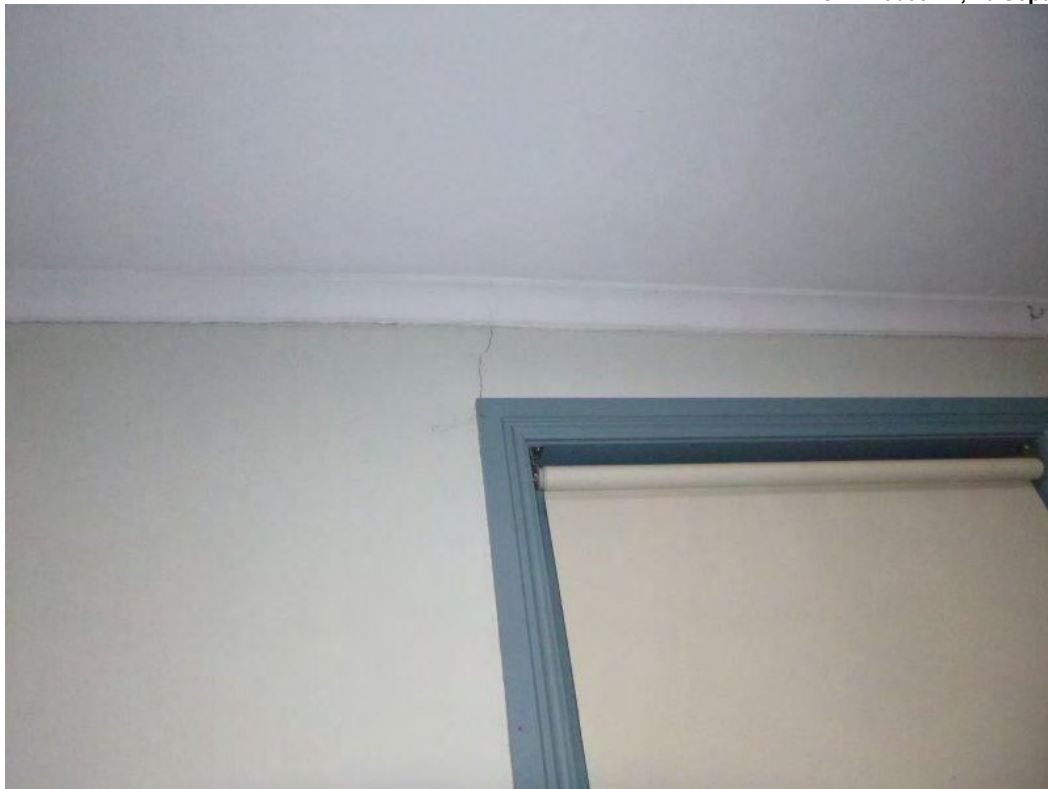
Photo 57 - Internal.jpg

Up to 70mm of relative level difference was measured across the central hall area with the southern side being higher relative to the northern areas. Some relatively minor cracking was noted on the southern wall (Photo 57, 58, 60). A localised level anomaly was observed in the north west corner of child care nursery with up to 60mm level difference between this room and the adjacent hall. Due to limited access at the time
